# **US 101 (Broadway) K-Mart to 4th St**

**Pedestrian and Bicycle Road Safety Audit**

**Humboldt County, California**

**August 25-28, 2008**

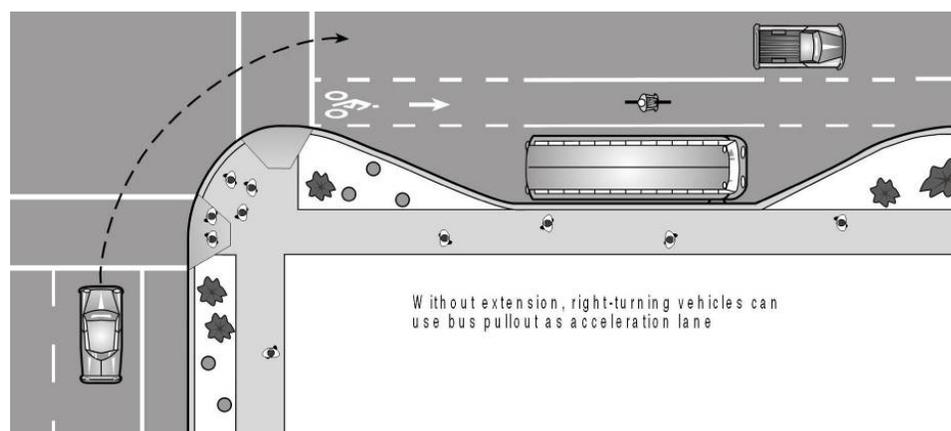
**Figure 4. The New Bus Stop Design Concept Applied at the Corner of Broadway and West Cedar Street (Source: Oregon Bicycle and Pedestrian Plan).**

- **New Bus Stop Design** – The owner/developer of the Broadway Cinema recently installed a bus bay with a shelter through the Caltrans encroachment permit process and it is located at the corner of Broadway and West Cedar Street. The bus bay design includes a bulb-out to prevent vehicles from using the bay as an acceleration lane and helps to reduce the speeds of vehicles turning right onto Broadway (see Figure 4).
