Appendix C. Captioned Photographs of Selected Sites

Racin, James A., Hoover, Thomas P., and Crossett Avila, Catherine M., **California Bank and Shore Rock Slope Protection Design - Practitioner's Guide and Field Evaluations of Riprap Methods**, report number FHWA-CA-TL-95-10, California Department of Transportation, Sacramento, CA, 3rd Internet edition, October, 2000, revised Appendix C, 1 Jan 2004.

Jim Racin, P. E. 1 Jan 2004 Office of Highway Drainage Design CA DOT Sacramento, CA.

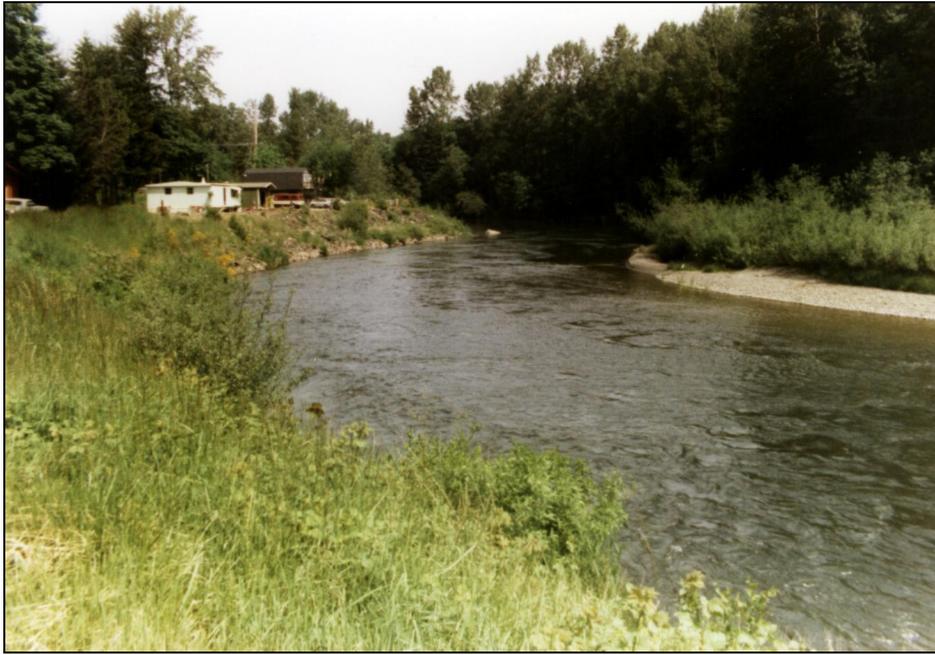
Photo C-1. Parallel and impinging flow. D/S view. Abundant vegetation where flow is parallel to riprapped bank (left foreground), as contrasted to the same bank farther downstream, where flow impinges on the outside of bend. Natural sand bar (right bank) is typical of the inside of bends of rivers.
Site 1 WA Nisqually R. May 1992

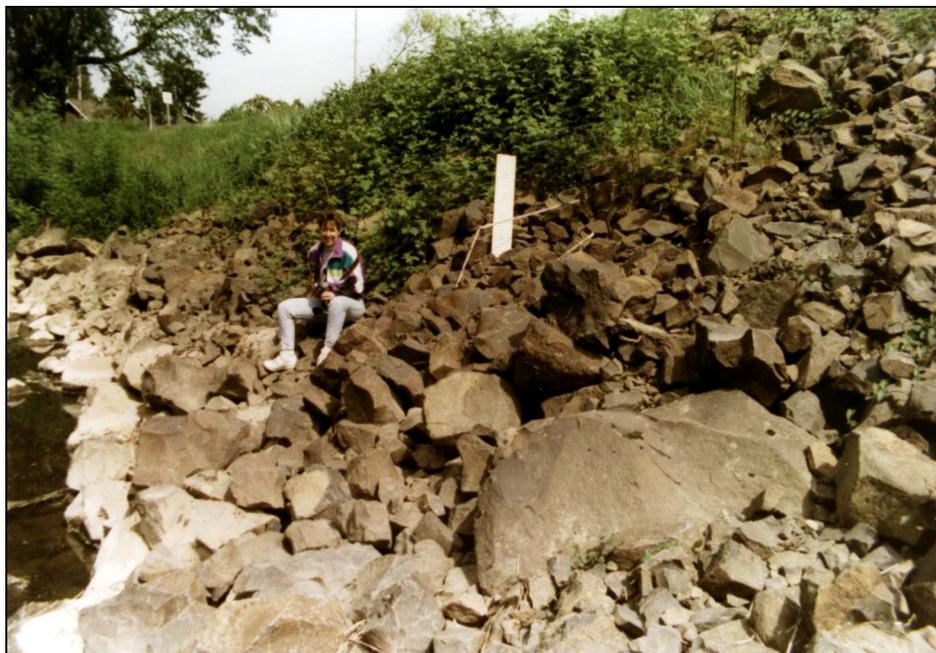
Photo C-3. U/S view from top of impinged bank at 90 degree bend.

During 1989, flood debris (a tree, like a battering ram) punched a hole in the riprap, the dike breached, and flooding occurred. No riprap along U/S banks, dense tree growth provides shade and riparian habitat.
Site 2 WA Skookumchuck R. May 1992

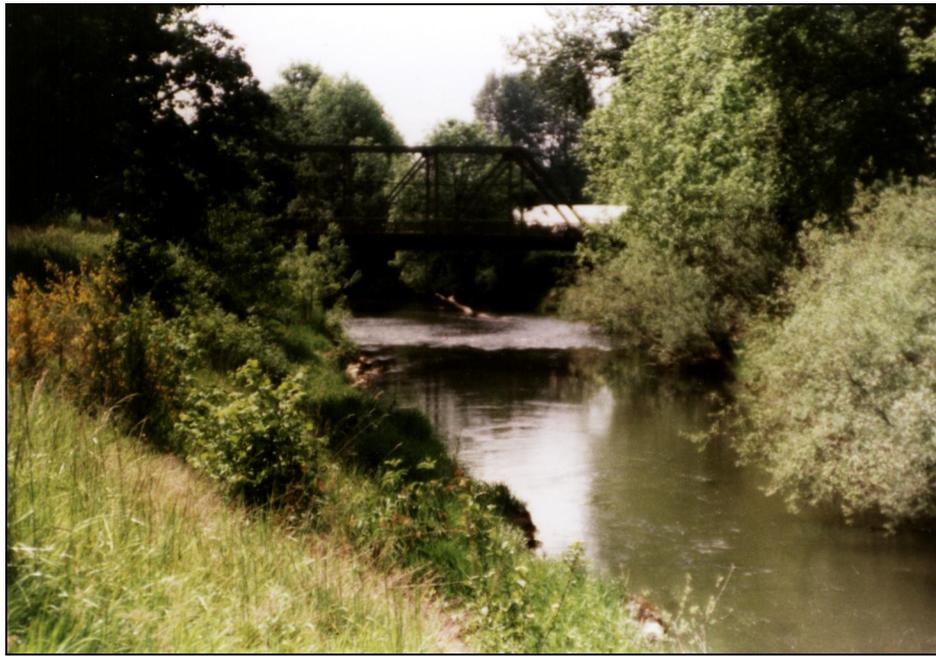
Photo C-4. Repaired zone of impinged bank at 90 degree bend. U/S view.

Specified Seattle Corps Class II riprap 500#-25# W50 200#, but delivered riprap is about W50 50#. z-scale: 30-inches high by 5-inches wide.
Site 2 WA Skookumchuck R. May 1992

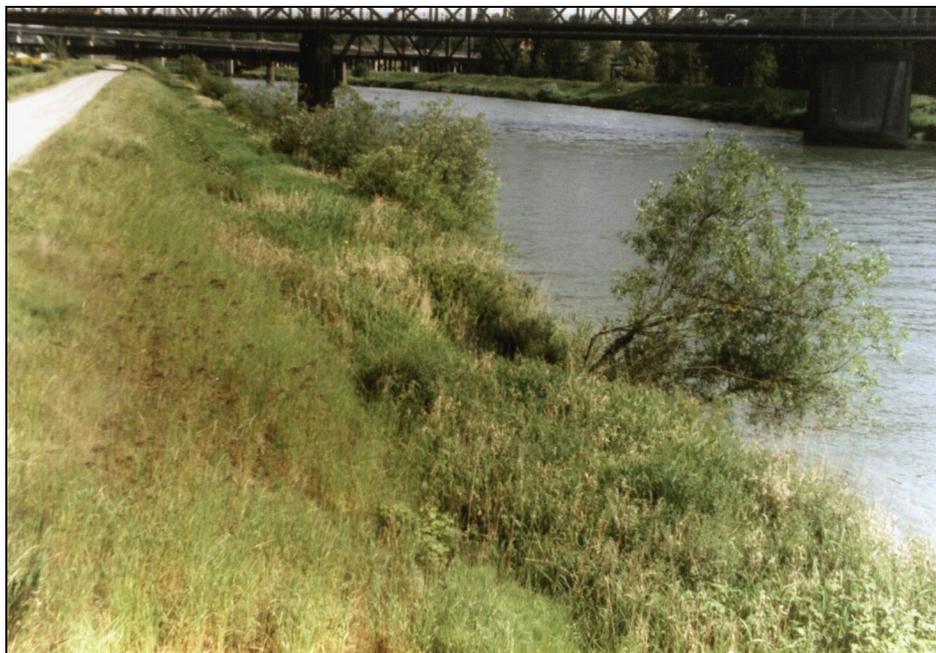
Photo C-5. Maintained dike bank (left) and natural bank (right). D/S view. Left bank is riprapped, and vegetation volunteered among rock voids. 1989 flood overtopped dike here (left bank). Right bank is natural. Site 2 WA Skookumchuck R. May 1992

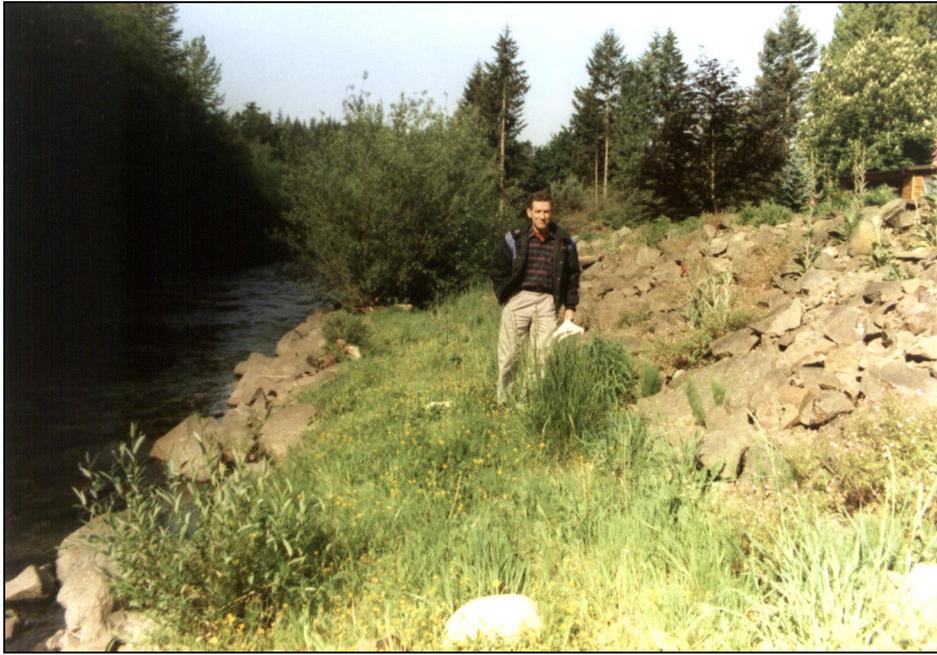
Photo C-6. Partially toppled willow. U/S view.
Willows planted at 25-foot intervals on silt-covered riprap.
1000-feet of toe was repaired in 1970. Site 3 WA Puyallup R. May 1992

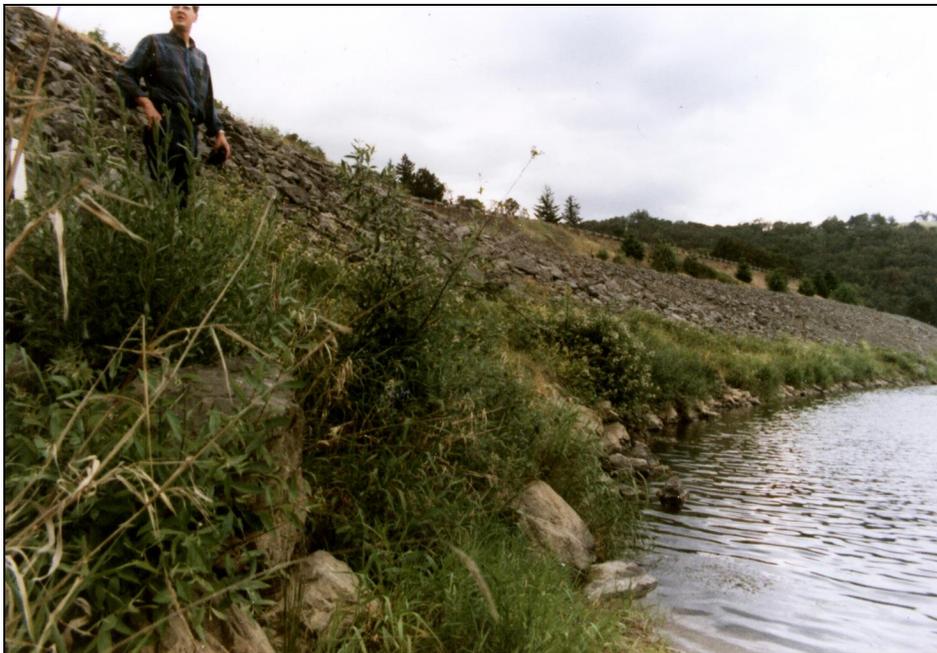
Photo C-17. RSP tied to solid rock outcrop, natural impermeable retard (jetty).
U/S view. Designed slide repair encroaches in river, was okay by permit.
Site 10 OR South Umpqua R. May 1992

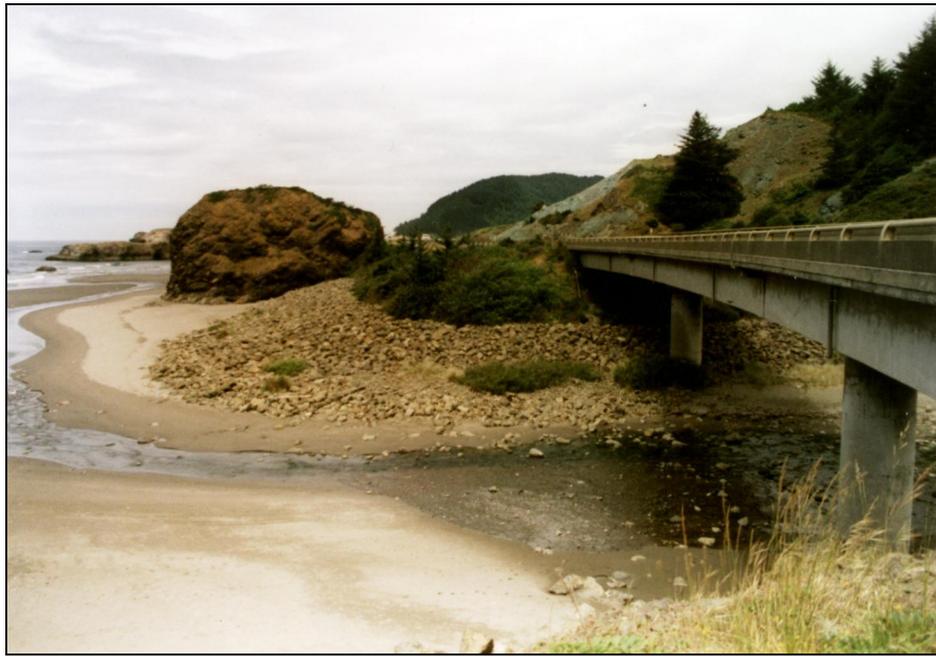
Photo C-22. Layered RSP protects bridge abutment fill. Southerly abutment fill. Layered RSP is (Class 2000, Class 50, geotextile). River flows toward right at low and ebb tides. Channel to ocean on right.
Site 12 OR Pistol R. and Beach 19 May 1992

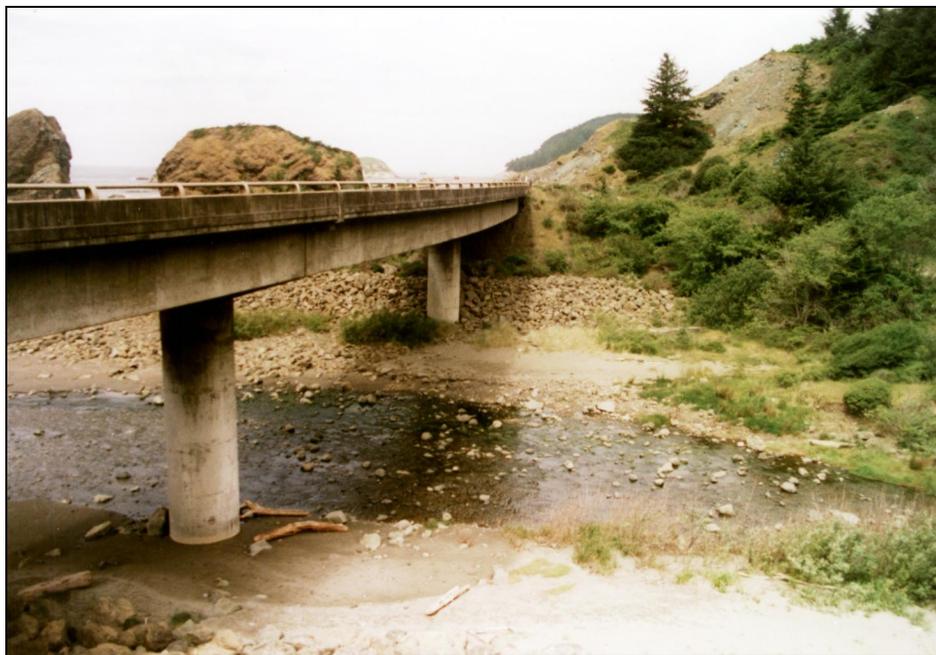
Photo C-23. Lighter rocks of well-graded mixture displaced by storm waves, 1 of 2.
View of northerly abutment fill, D/S of bridge. Class 2000 (2000#-40# W50 700#), well-graded.
Creek flows toward left at low and ebb tides. Ocean wave attack is from left.
Site 13 OR Myers Creek and Beach 19 May 1992

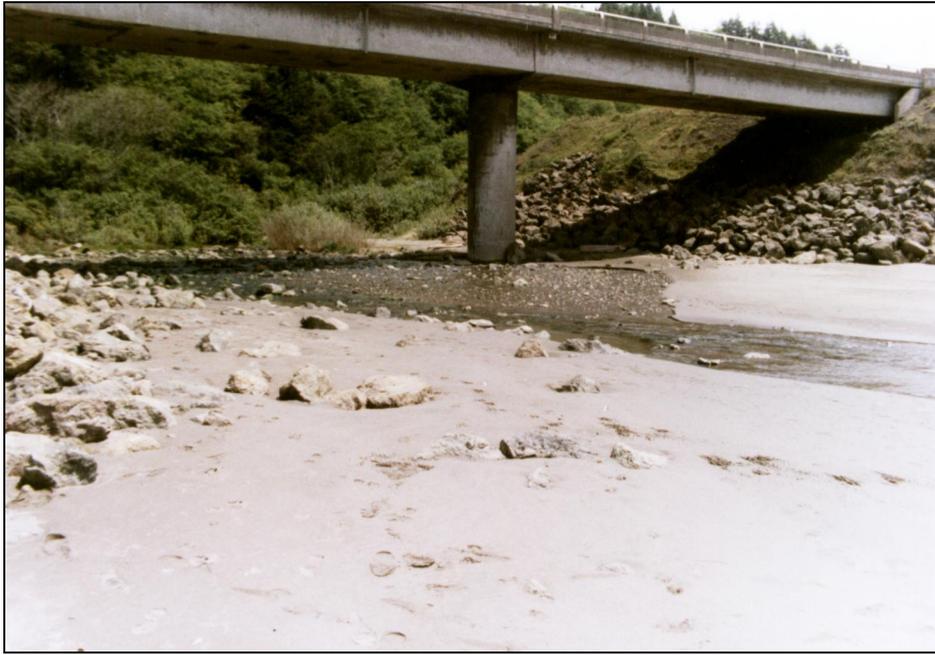
Photo C-24. Lighter rocks of well-graded mixture displaced by storm waves, 2 of 2.
View of northerly abutment fill, U/S of bridge. Class 2000 (2000#-40# W50 700#), well-graded.
Site 13 OR Myers Creek and Beach 19 May 1992

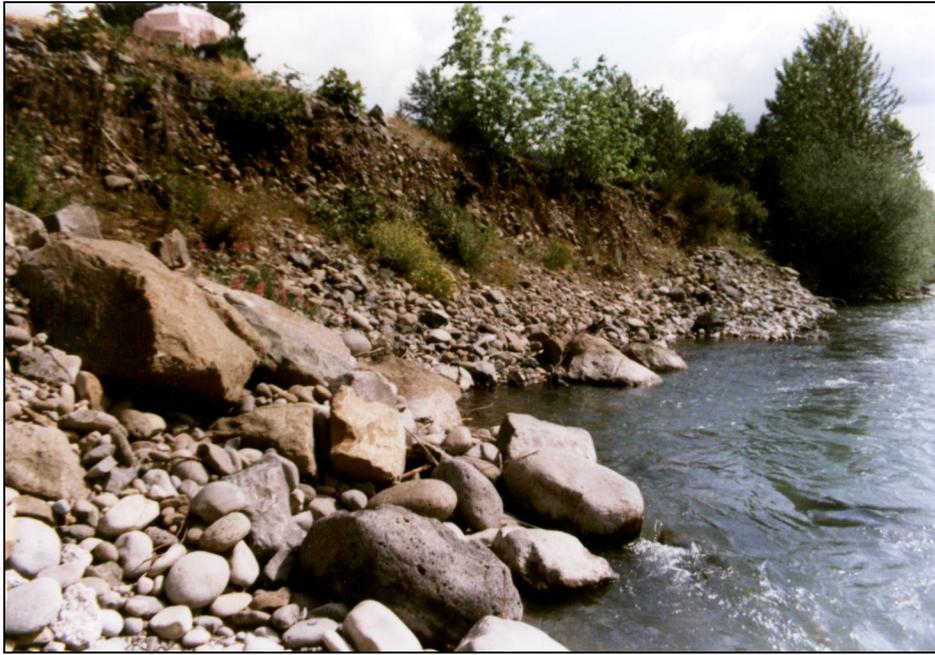
Photo C-26. Outside layer (primary cover stone) 2070#-1240#. View of Southerly abutment riprap. Fewer rocks displaced as contrasted to standard Class 2000. 30-inch high by 5-inch wide z-scale and 6-foot wide folding rule.
Site 13 OR Myers Creek and Beach 19 May 1992

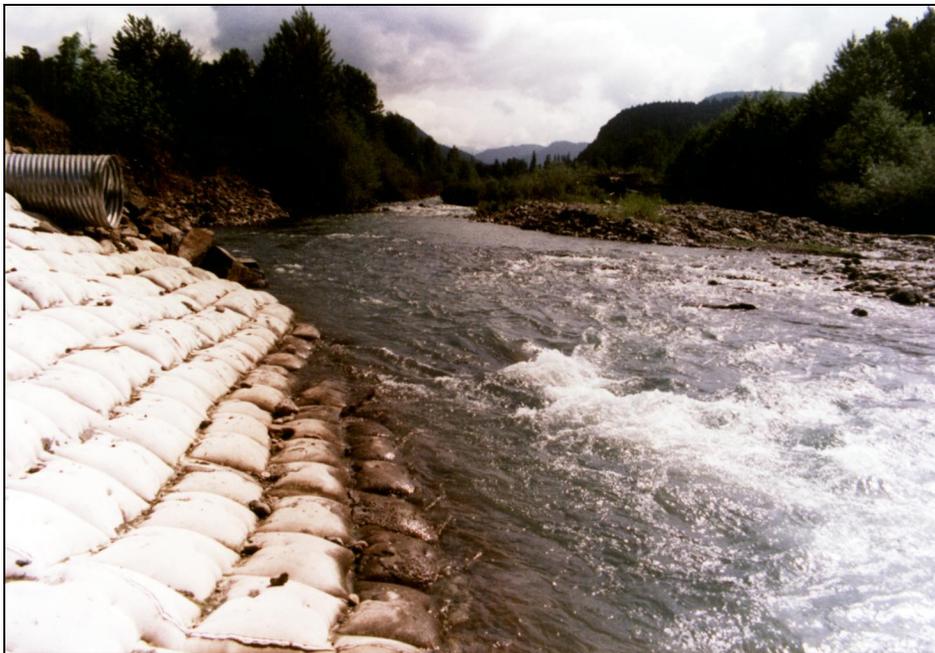
Photo C-27. Failed riprap on levee bank. U/S view, westerly bank just U/S of Route 58 bridge. Failure was due to round rock on oversteepened backslope, no filter layer, low and mid-range flow angles that impinged on banks due to shifting gravel bars and debris. Levee bank slopes were designed and built at 1V:2H using the parallel flow assumption. Site 14 OR Salmon Creek May 1992

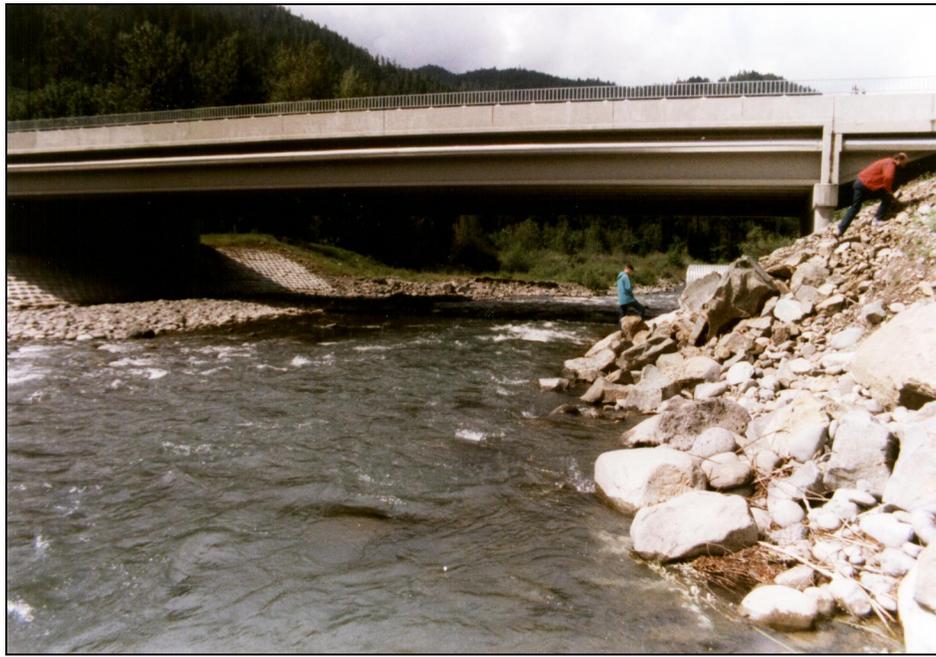
Photo C-28. Gravel bar (2nd one U/S) directs impinging flow at westerly bank (left). U/S view. Degraded channel partly due to in-stream sand and gravel removal, which provided about 6-feet additional depth capacity. Route 58 westerly bridge abutment fill protected with concrete-filled fabric. Site 14 OR Salmon Creek May 1992

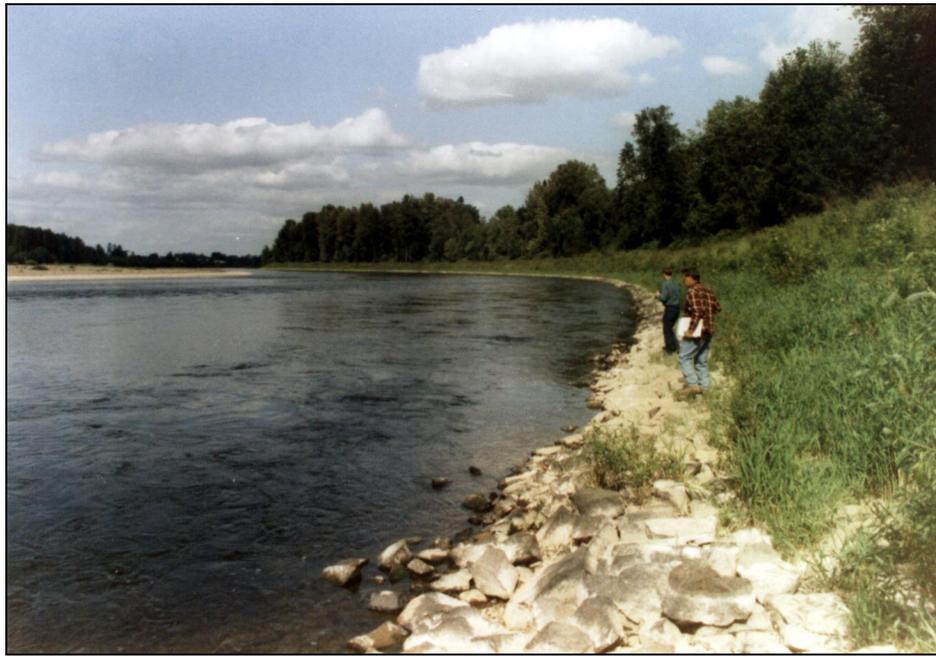
Photo C-32. OR Keyed Riprap, close-up at left bank. D/S view at impinging zone. Class III (800#-25# W50 300#) over 1-foot Class 50 filter layer. Rock is visible below surface. Natural siltation and vegetation about 3-feet higher than water surface. Site 15 OR South Santiam R. May 1992

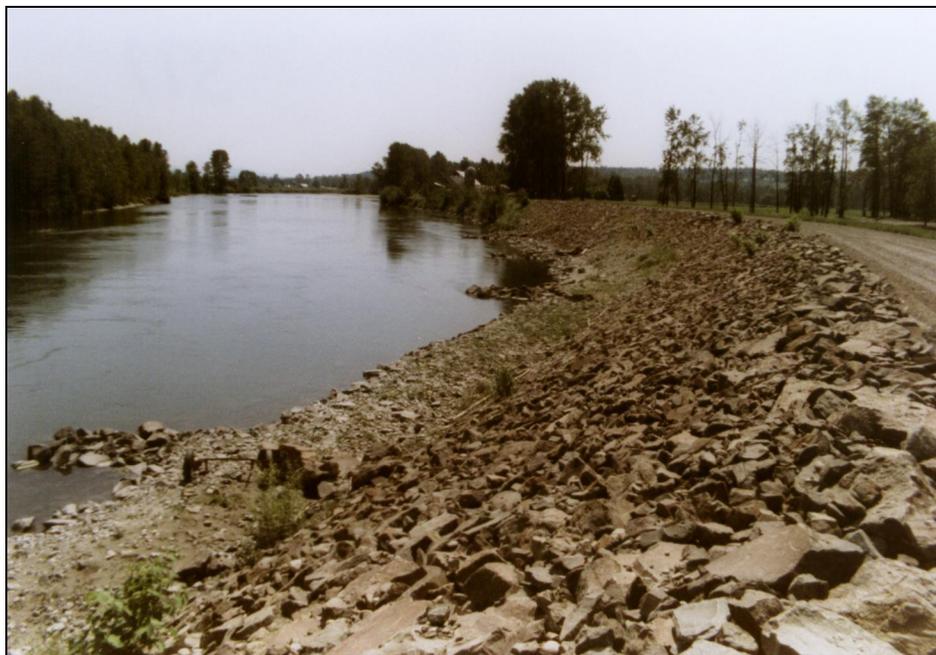
Photo C-33. Keyed riprap by Corps of Engineers, Portland. D/S view. Impinging flow on bank of Minto Brown Island. Class 700 (700#-20# W50 200#) extends up bank with natural vegetation to base of trees. Island is flooded every 2-3 years. Bank gets overtopped about 8 feet above base of trees.
Site 16 OR Willamette R. 20 May 1992

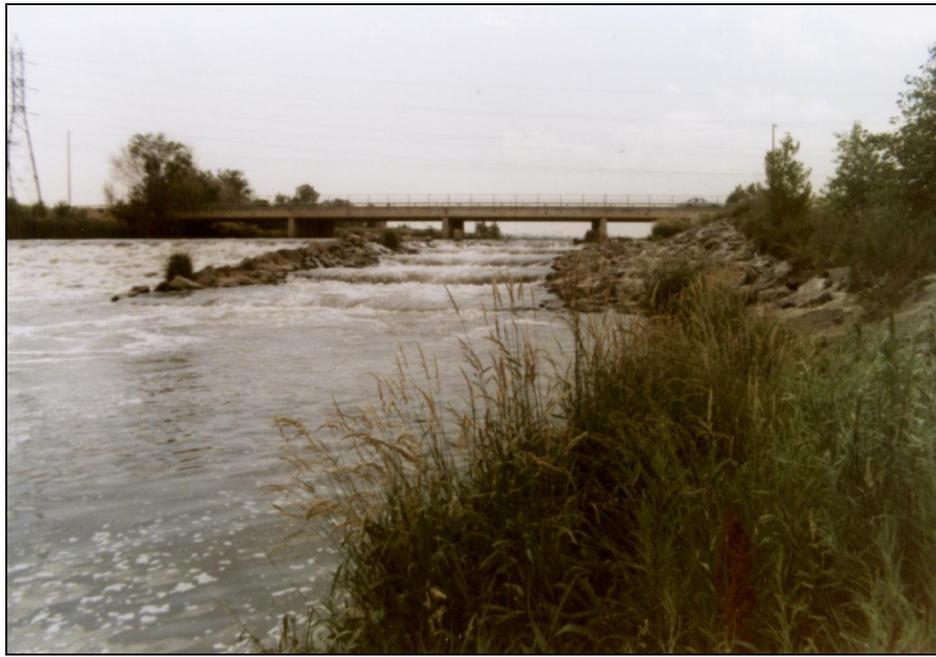
Photo C-34. Keyed riprap by Corps of Engineers, Seattle. D/S view. Impinging flow along Hansen Dike. Repaired 1991, 60-inch thick Class V (1800#-25# W50 750#) and gravel bedding. Rock keyed by pounding surface with 2-cubic yard bucket of excavator. Note rock groins for improved fish habitat.
Site 9 WA Skykomish R. 14 May 1992

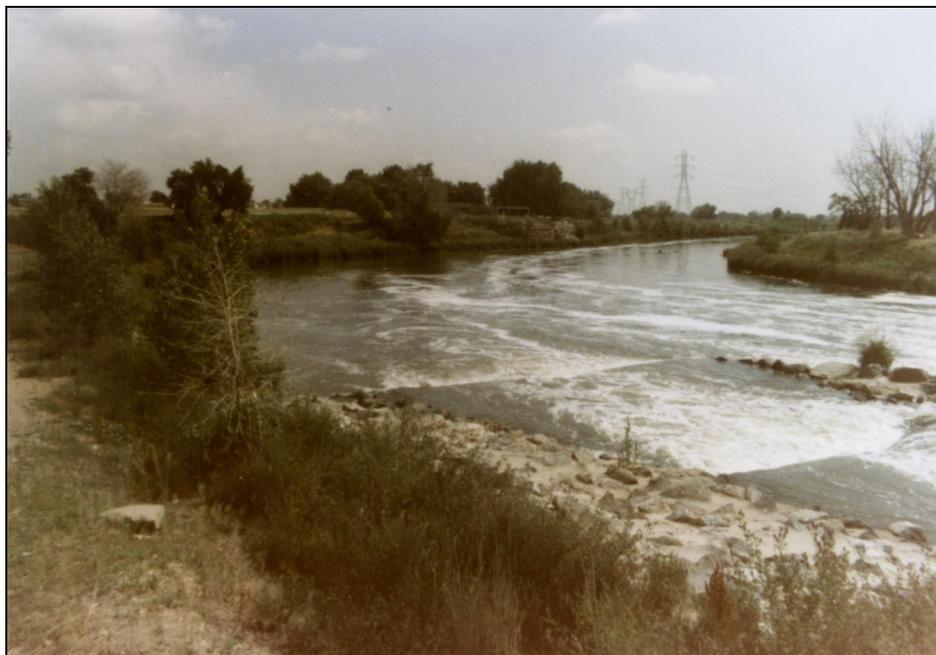
Photo C-35. 88th Avenue, 1 of 4. U/S view. At end of concreted rock drop structure and hidden by vegetation in right foreground is Type L riprap (repaired washout of Very Light riprap). Right half of drop structure is stepped pools for recreational users, left half is continuously sloped for oxygenation.
Site 20 CO South Platte R. 16 Jun 1992

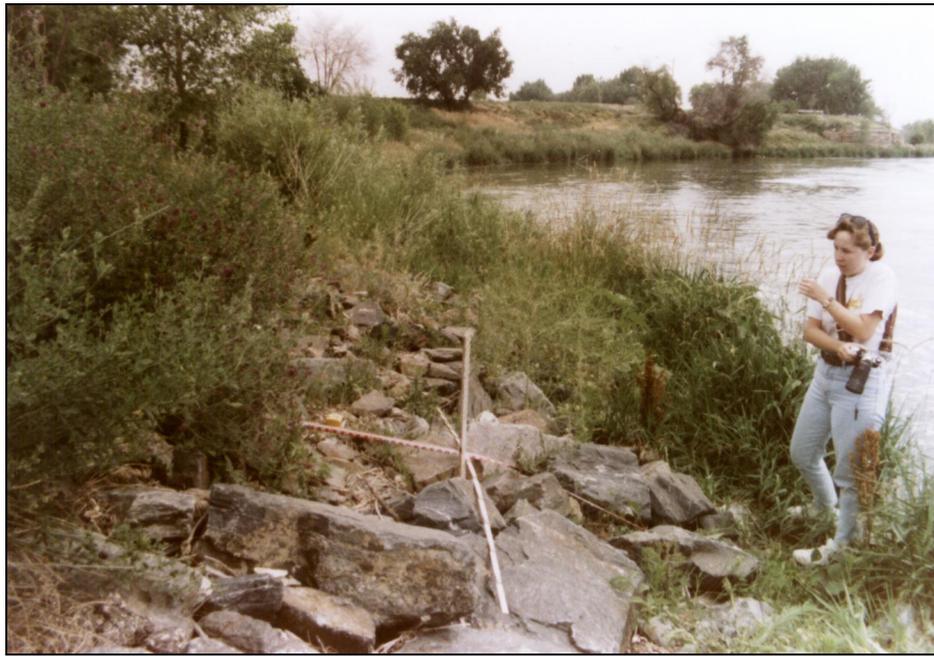
Photo C-36. 88th Avenue, 2 of 4. D/S view. Last pool of concreted rock drop structure. After drop structure dissipates energy, river turns sharply. Repaired zone of Type L riprap is just D/S to left, hidden by vegetation. Denver UDFCD rock size range (inches): <3 to 15, D50=9, D100=15.
Site 20 CO South Platte R. 16 Jun 1992

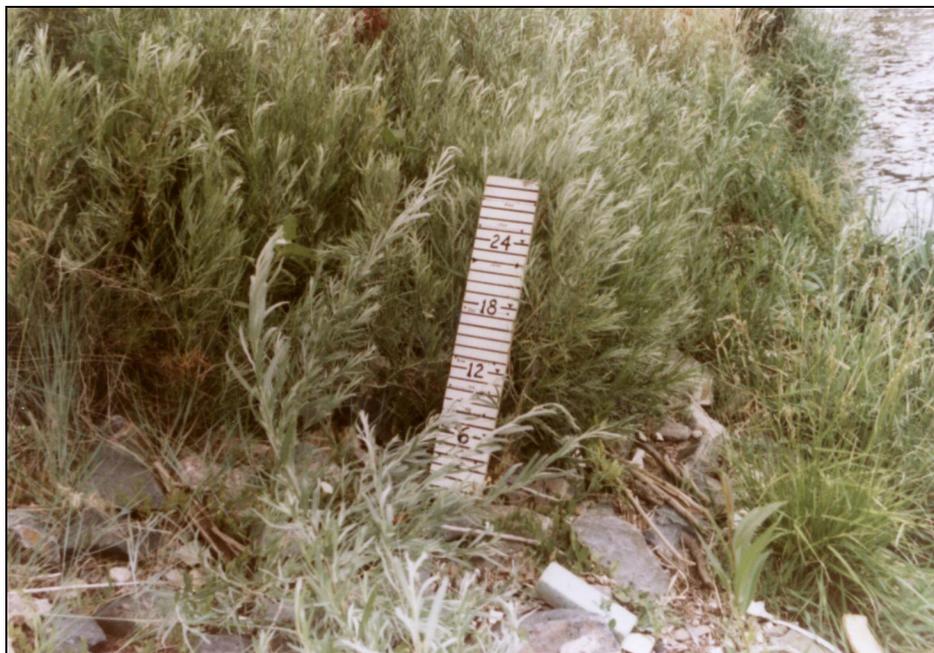
Photo C-37. 88th Avenue, 3 of 4. D/S view. Repaired zone at join with concreted rock drop structure is Type L riprap and willows, withstood flow rate >12,000 cfs. x and y scales: 6-foot ruler and 6-foot rod, z-scale: 30-inches high (looking at edge of ¼-inch plywood).
Site 20 CO South Platte R. 16 Jun 1992

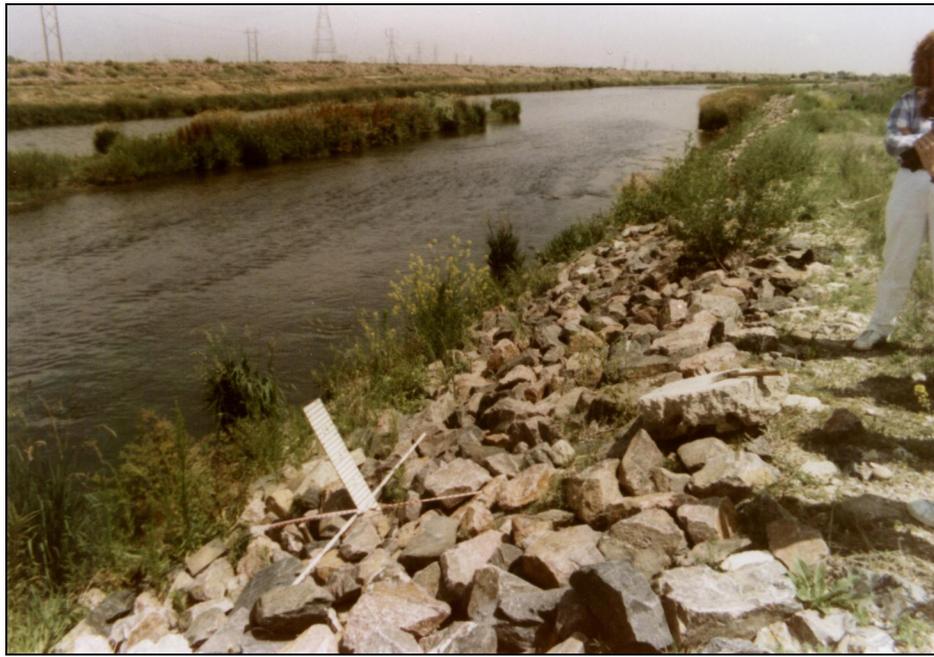
Photo C-38. 88th Avenue, 4 of 4. D/S view. Repaired zone of Type L riprap and willows. Sandbar willow (probably *Salix exigua*) was selected because it bends easily and offers less flow resistance than some other tree families, when exposed to river currents during high river stages.
Site 20 CO South Platte R. 16 Jun 1992

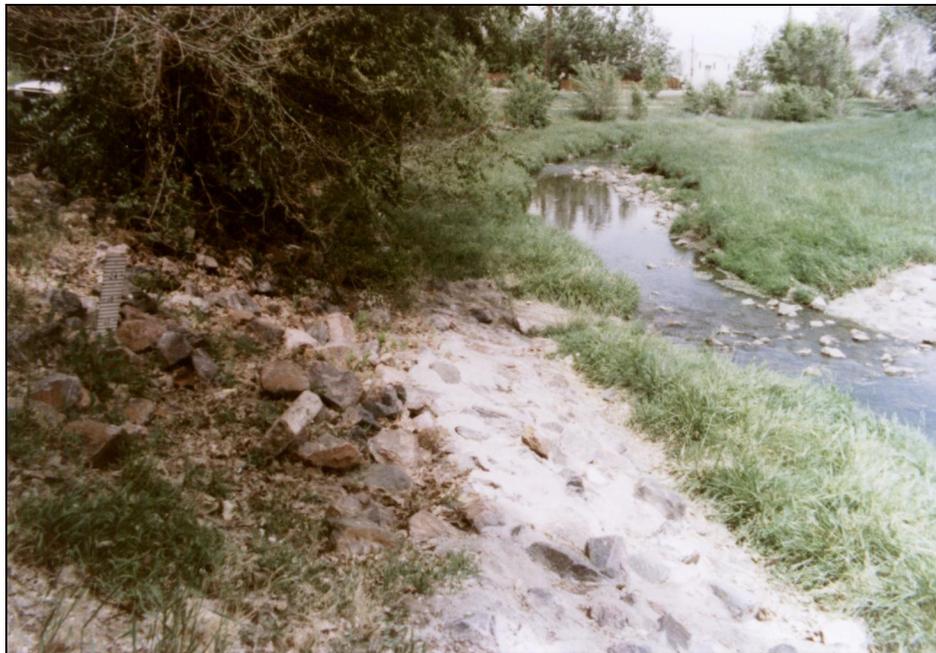
Photo C-43. Denver UDFCD Type L riprap below 3-foot drop structure failed, repaired with concreted rock. U/S view. Urban multiple-use flood control: park during dry season with trickle flow, open channel for storm runoff and snowmelt. Site 23 CO Sanderson Gulch 16 Jun 1992

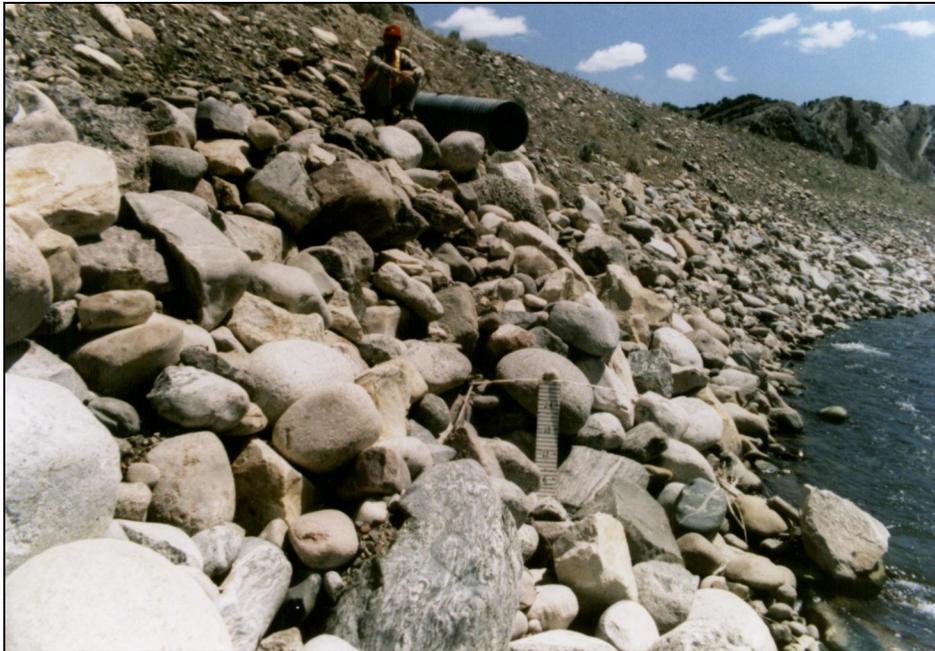
Photo C-45. Permeable rock retard (jetty) and check dam. U/S view.
Previously natural embankment was undercut by impinging flow and failed.
I-70 roadway embankment reconstructed at 1V:1.5H.
Protected with CO DOT HEAVY riprap, size ranges: 1280#-10# W50 275#.
Site 26 CO Eagle R. 17 Jun 1992

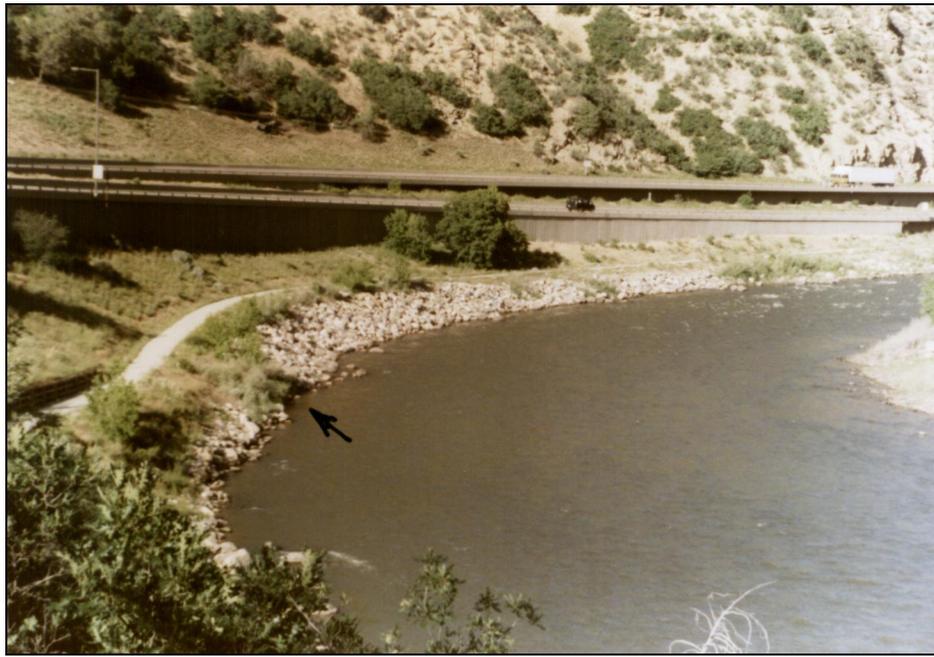
Photo C-48. Willows growing well through concreted-RSP. View normal to riprap. Experiment by CO DOT : willows were planted among riprap voids, then concrete was placed. Result : willows grew OK. I-70 Glenwood Canyon Bikeway, Grizzly to Shoshone. Site 27 CO Colorado R. 17 Jun 1992

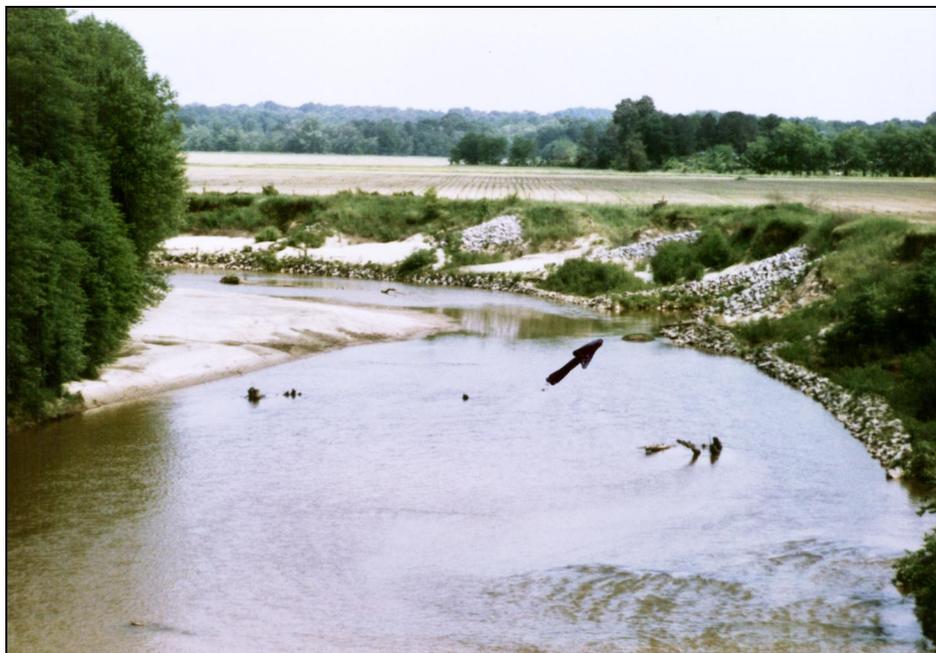
Photo C-53. Longitudinal stone toe and tieback (permeable rock retard, hard-point dike). U/S view. Longitudinal toe controls meander and parallels creek, while tie-backs are roughly perpendicular and trap sediment. USACE R200 class, maximum weight 200# W50 50#. Natural willow growth among rocks. 30-inch high by 5-inch wide z-scale. Site 33 MS Black Creek 19 May 1993

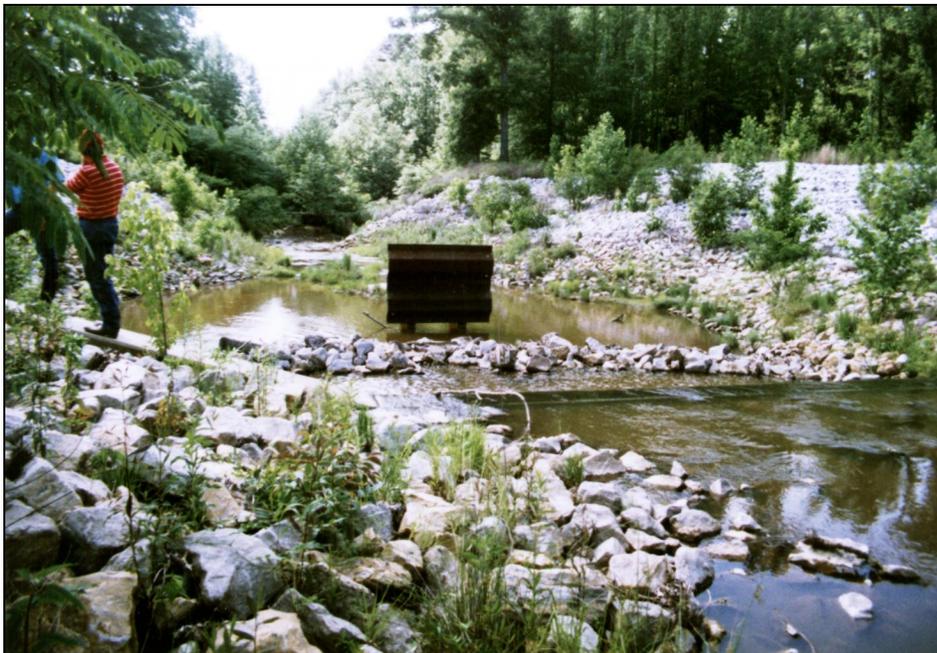
Photo C-57. Grade control structure with failed R400 riprap, 1 of 2.
U/S view, a few hundred yards D/S of bridge in Photo C-55. R400 (400#- 30# W50 160#) washed about 20 feet D/S of 4-foot drop structure (weir). Scour hole (downcutting and headcut migration upstream) next to weir threatens long-term stability of weir. Site 38 MS Worsham Cr. 19 May 1993

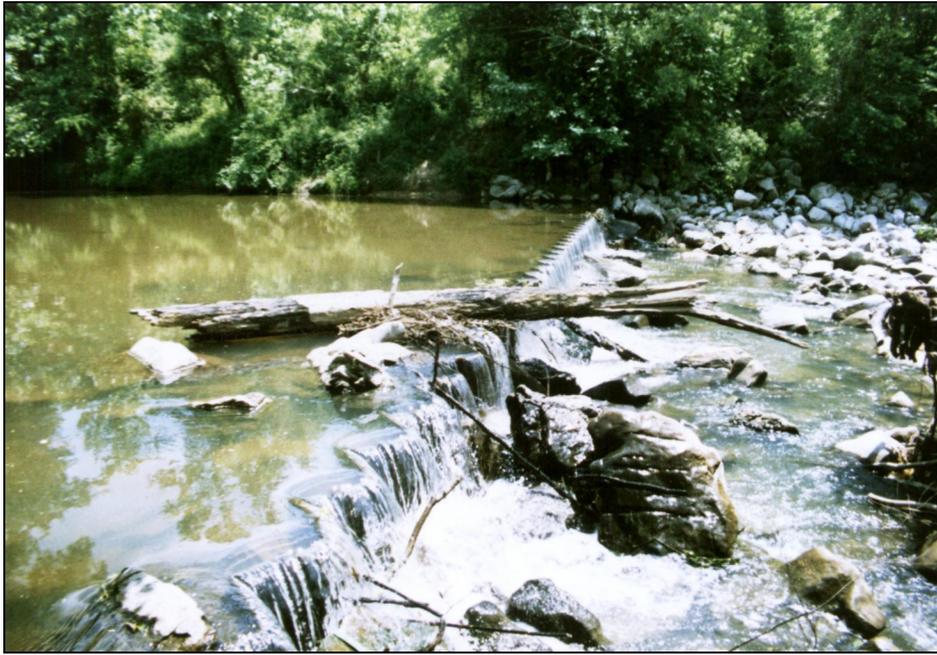
Photo C-58. Grade control structure with failed R400 riprap, 2 of 2.
D/S view, a few hundred yards D/S of bridge in Photo C-55. R400 washed about 20 feet D/S of weir. Baffle about 75-feet D/S of drop, where stream is about 2-3 times wider than normal. Naturally occurring trees on riprapped banks. Site 38 MS Worsham Cr. 19 MAY 1993

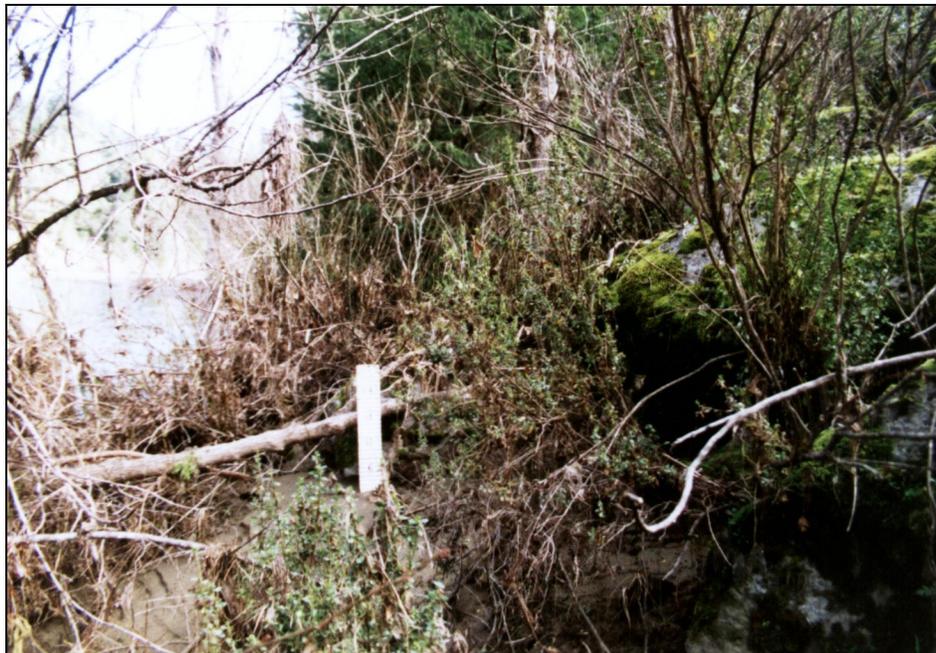
Photo C-61. Dense vegetation naturally regenerated among riprap on impinging (left) bank. D/S view, 1/3 way up slope from low flow (non-storm) water surface, US 101 at top of slope. Recent high water indicated by debris hanging on tree. Impinging flow on this bank is caused by a protruding natural rock outcrop (not visible), upstream on opposite bank. Site 53 CA South Fork Eel River 13 Feb 1996

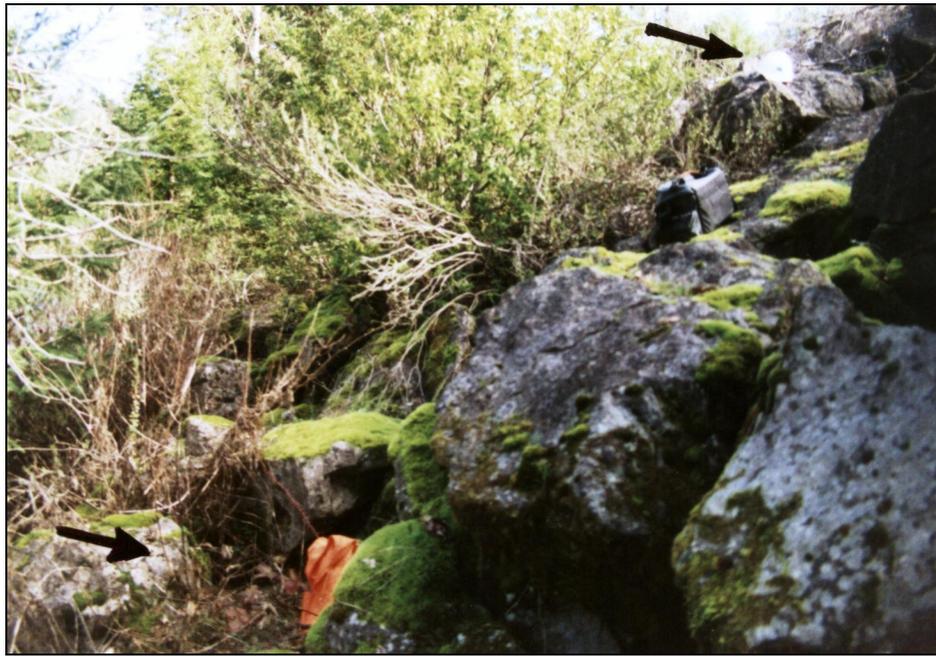
Photo C-62. Dense vegetation in naturally silt-filled voids of riprap. U/S view near site of Photo C-61. 30-inch high z-scale is 9 feet higher than water surface. Heights (elevation differences) : about 45 feet from US 101 to river and >50 feet to toe of riprap. RSP-class of lower half of slope : 1/2 ton as-designed, 4-ton as-built. Site 53 CA South Fork Eel River 13 Feb 1996

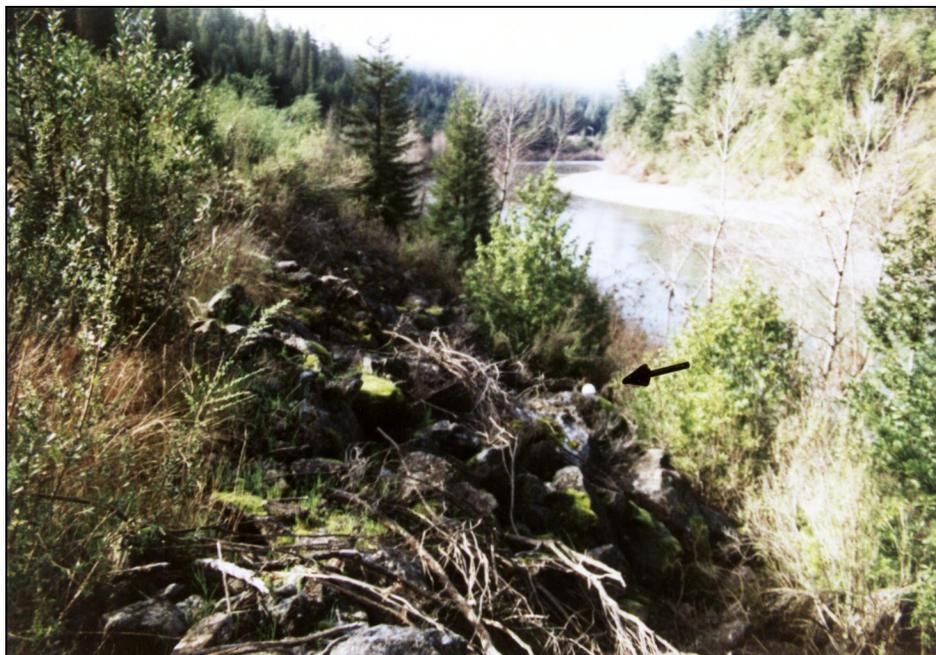
Photo C-63. Elevation limit of naturally deposited silt. U/S view, just above site of Photo C-62. Lower arrow (orange vest) shows limit of silt, 1/3 way up slope from river. Upper arrow (white hard hat) is near mid-slope. Site 53 CA South Fork Eel River 13 Feb 1996

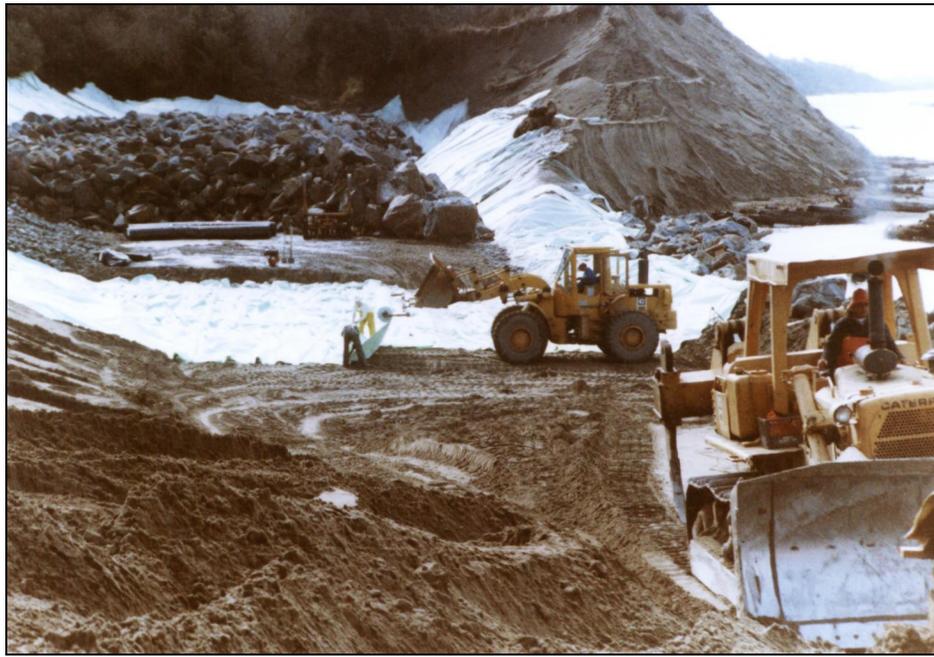
Photo C-70. Four-man team positioned and sewed RSP-fabric. From top to bottom of bank, one continuous prayer seam was stitched with nylon thread. Seam strength \geq RSP-fabric strength of 300-lb grab tensile strength was achieved. Stitched seams are required in this (and similar) severe setting of river currents and ocean tides. Site 59 CA Mad River 11 Feb 1992

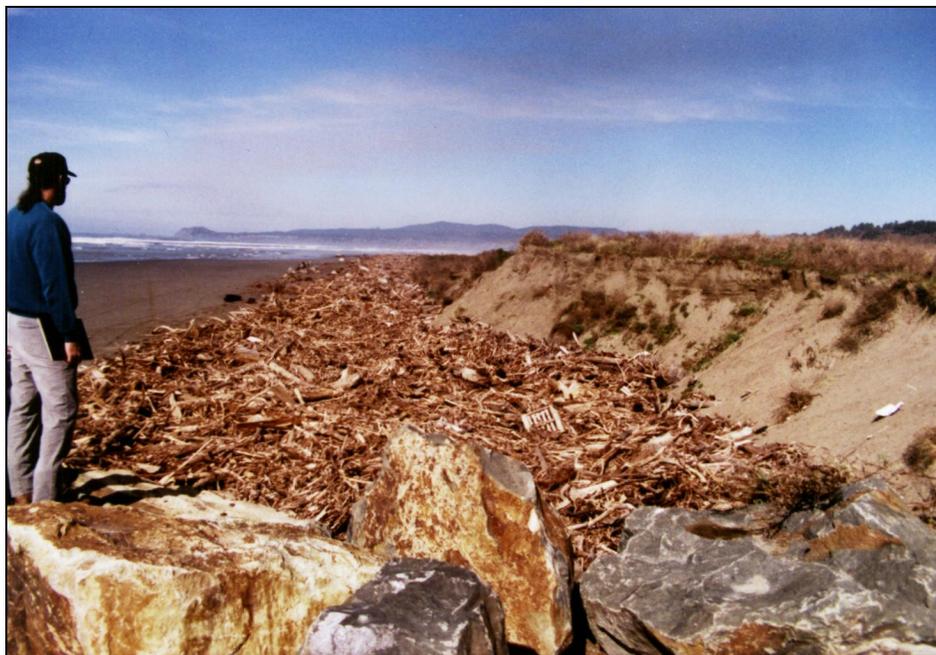
Photo C-79. West-turn RSP at mouth of Mad River after 3 years. Northerly view from vista point, center horizon Trinidad Head. West-turn built in 1992, same launchable layered design as in pit, see Photos C-71, 72 & 73. Moonstone Beach bluff is nearest natural rock outcrop, 3.8 miles north of vista point.
Site 59 CA Mad River May 1995
