1. REPORT NO.		2. GOVERNMENT ACCESSION NO.		3. RECIPIENT'S CATALOG NO.	
4. TITLE AND SUBTITLE Design Variables for Cut Slopes				5. REPORT DATE September 1973

Research Project
T.L. 632882
D-5-30

DESIGN VARIABLES
FOR
CUT SLOPES

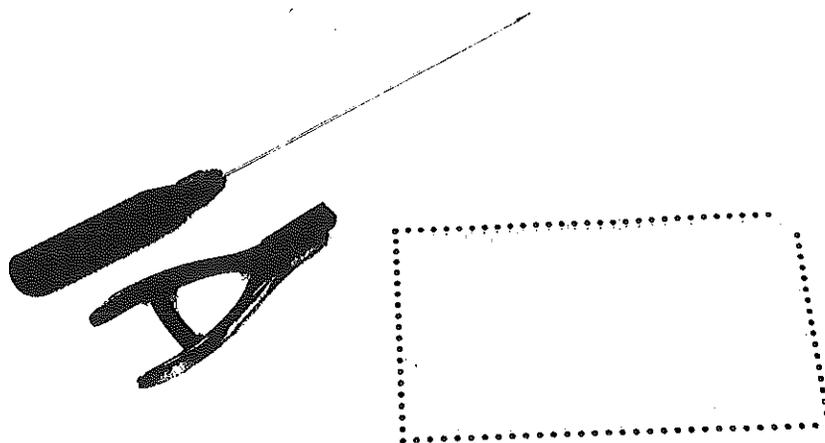
The data storage and retrieval system employed in this study was the Burroughs Corporation Unisort System. This system consists of 5 X 8 inch cards with 95 numbered holes around the edge. Data is recorded on the card and keyed to the holes which are then notched out. For data retrieval, a sorting needle is inserted into the hole keyed to the desired data and those cards which drop out of the card file are the ones desired. A blank card, the notching tool and a sorting needle are pictured below.

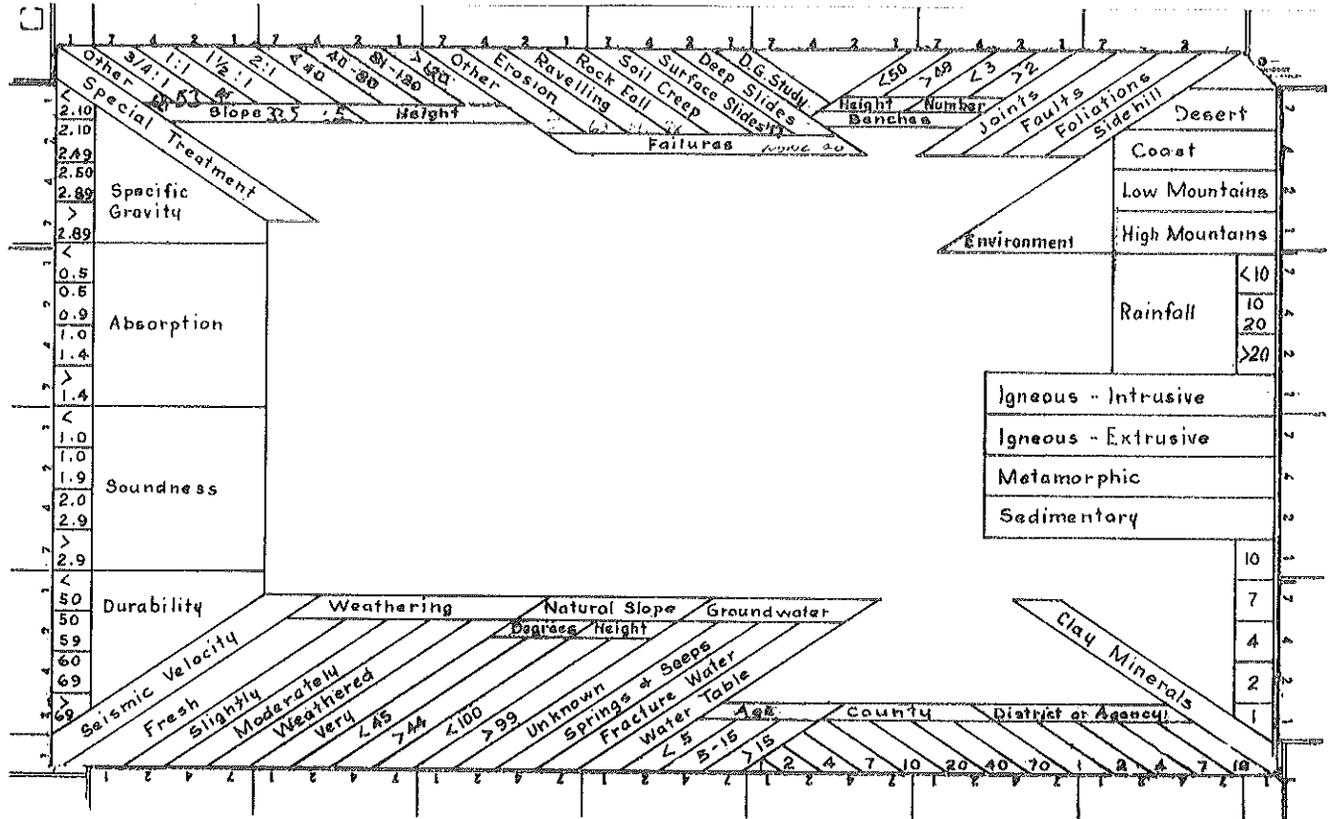
To facilitate the data retrieval an index card was developed. This card had the edge holes identified and could be placed in front of the card file to readily indicate the hole into which the needle should be inserted to retrieve the desired data. The index card is shown as follows:

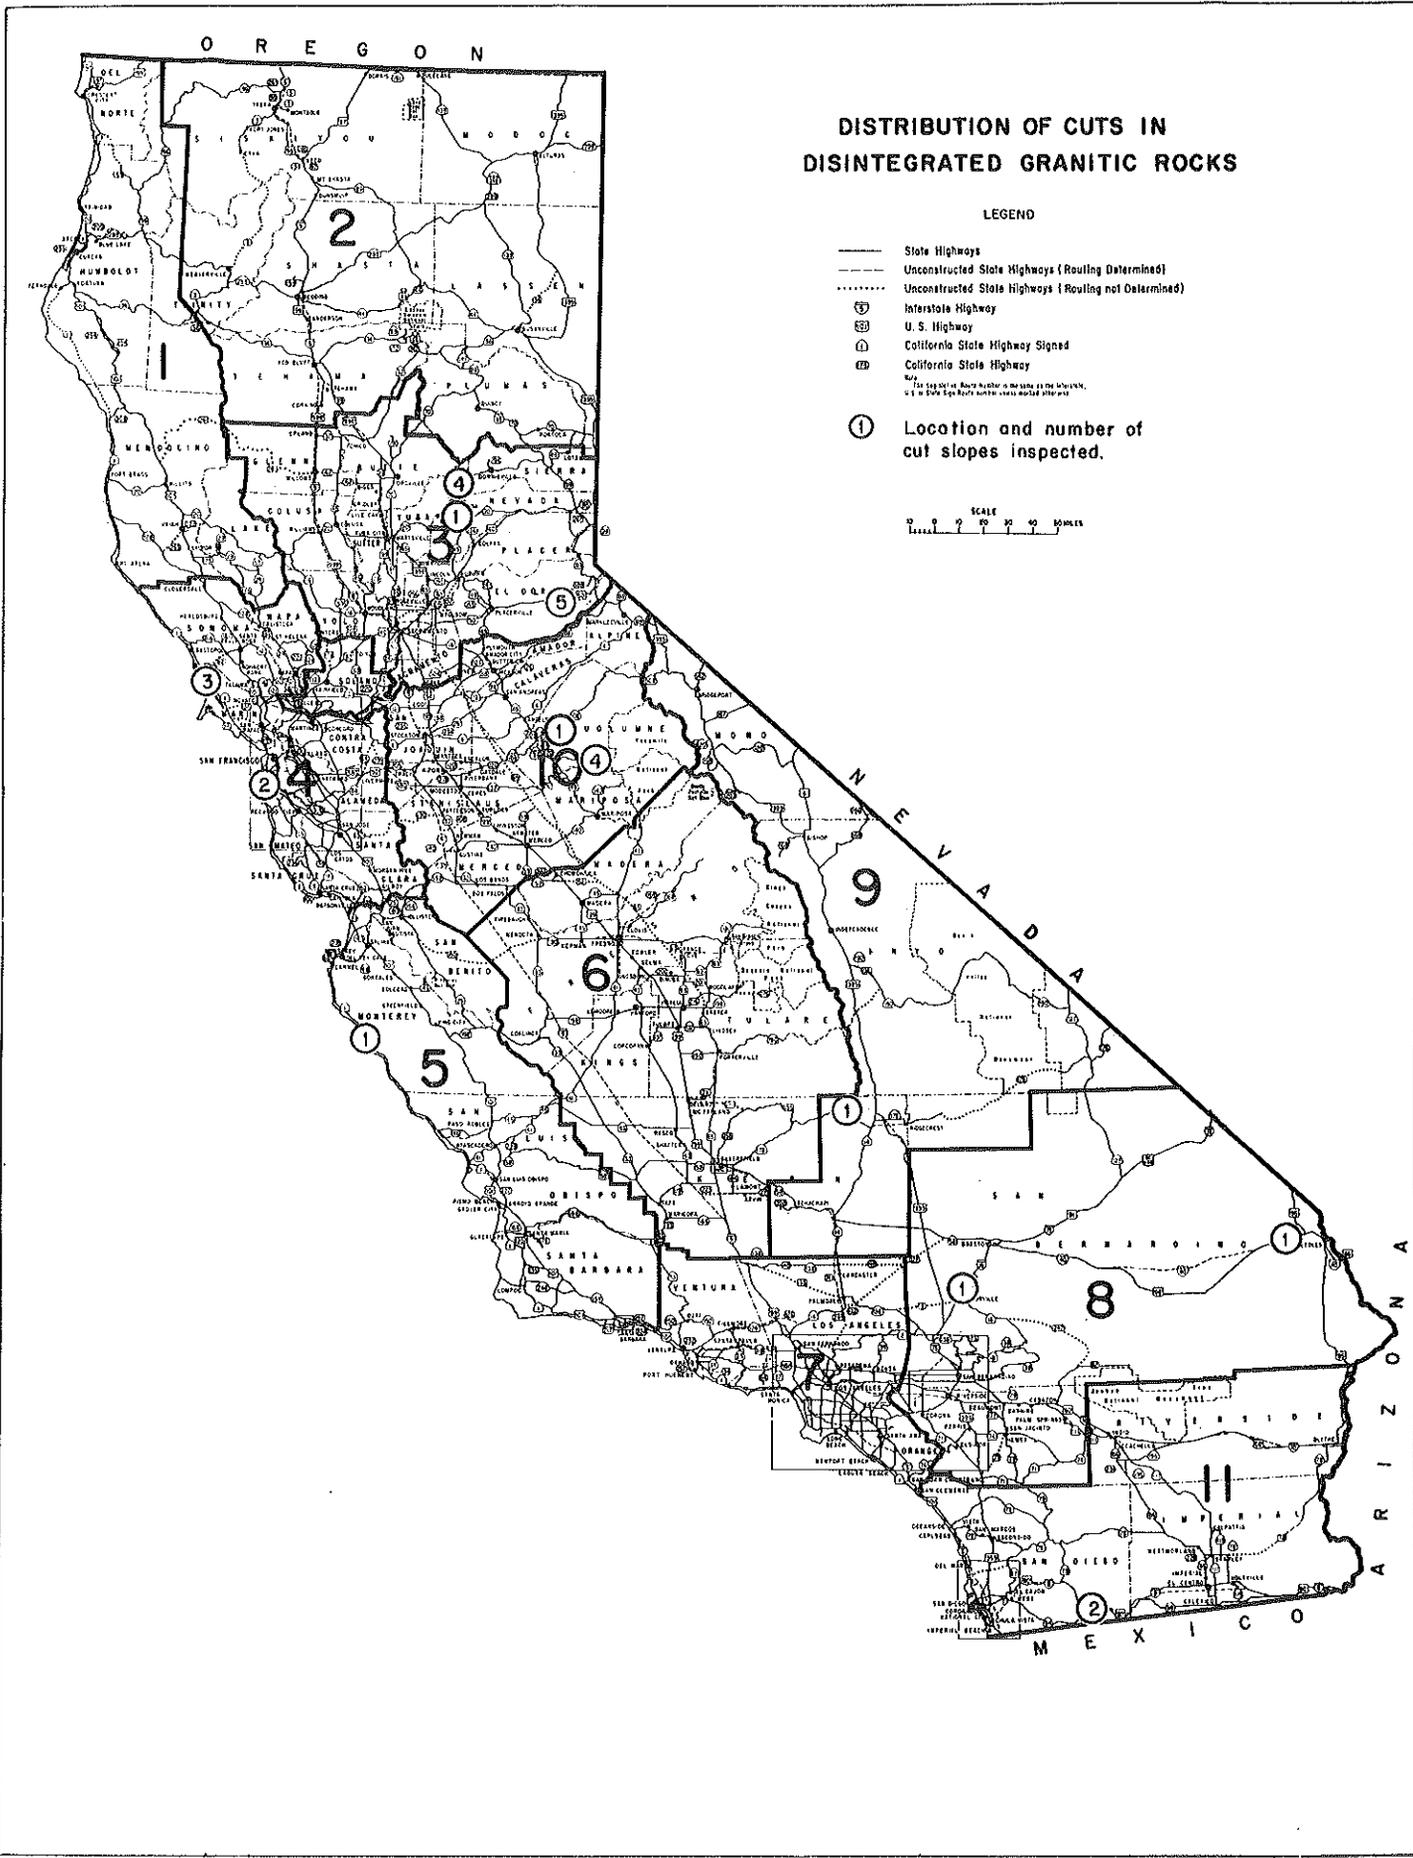
① Location and number of cut slopes inspected.

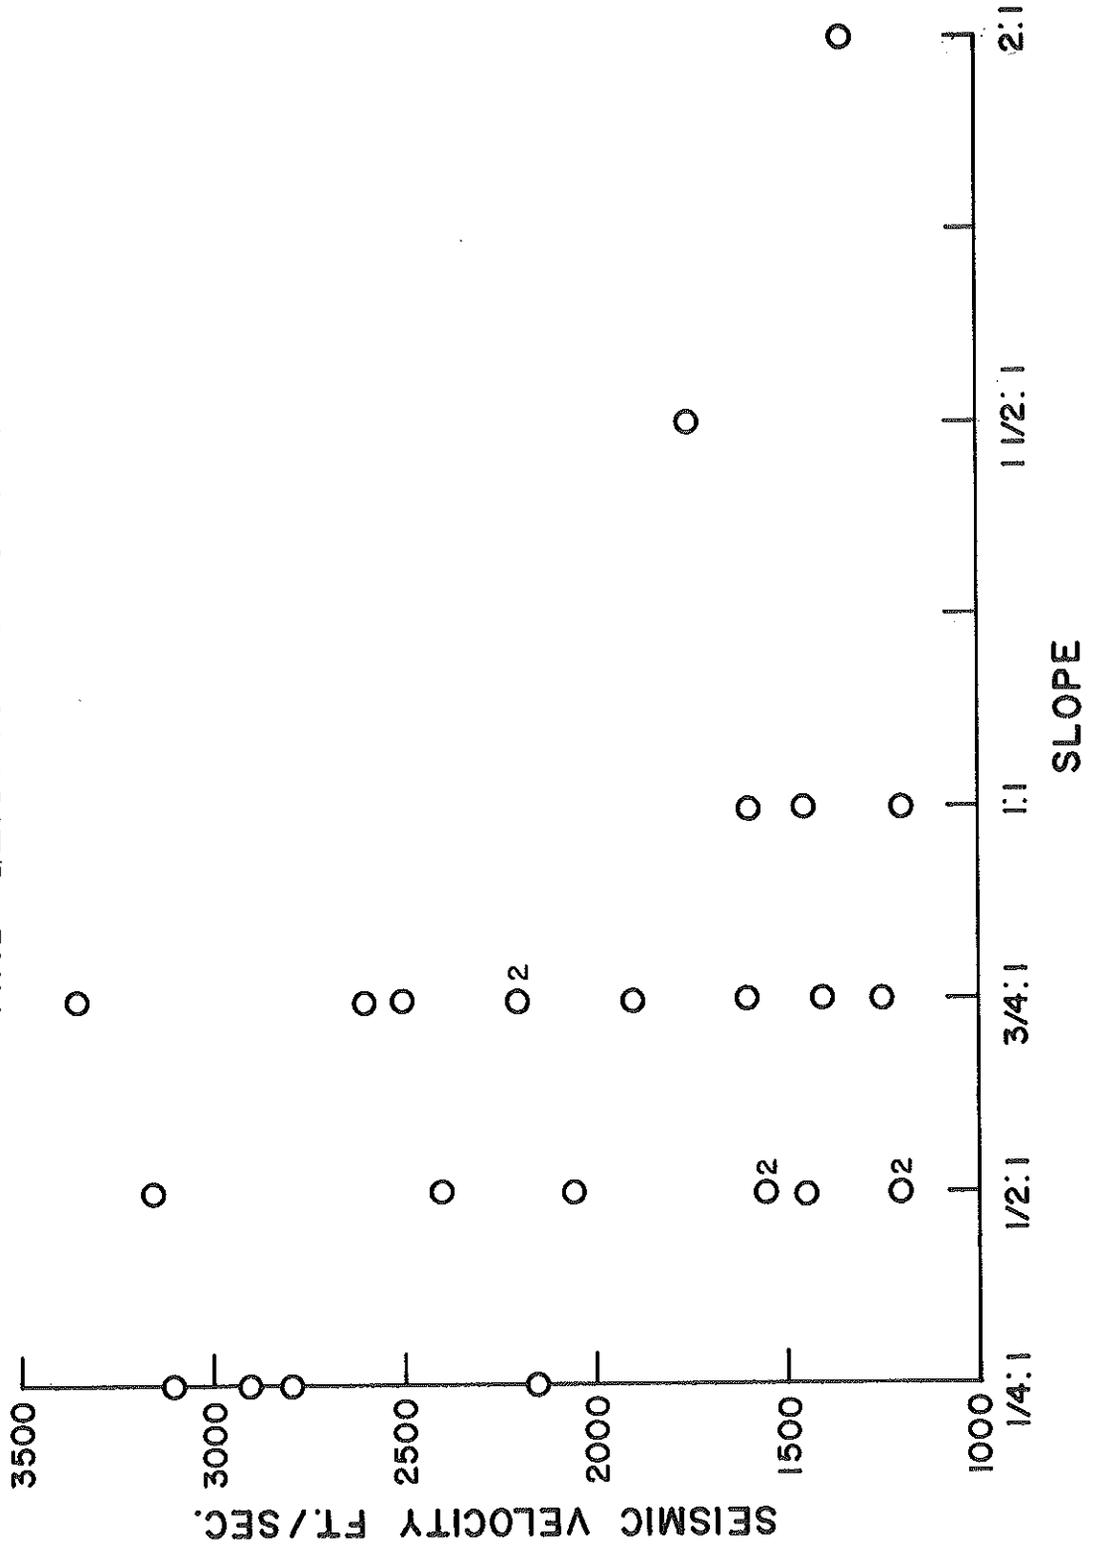
Figure 1

RELATIONSHIP BETWEEN STEEPEST STABLE SLOPE AND SEISMIC VELOCITY

As a result of some early work on this project and experience gained on routine seismic investigations, an apparent correlation between cut slope stability in disintegrated granitic rocks and seismic velocities was noted. To investigate this relationship and to put the findings into effect as soon as possible, research funds were obtained from the California Division of Highways. The results of this correlation study are presented in Appendix C and have proven to be a useful and reliable method of arriving at stable cut slope designs in disintegrated granitic rocks.

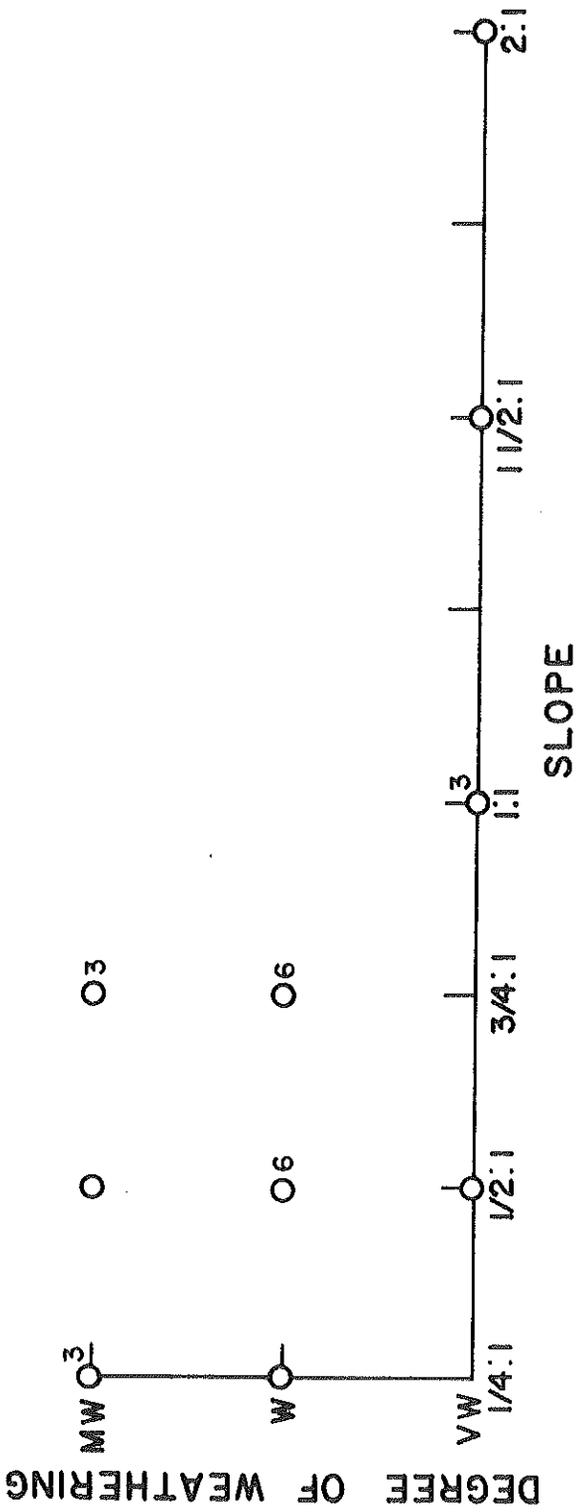
Figure 3

RELATIONSHIP BETWEEN STEEPEST STABLE SLOPE
AND DEGREE OF WEATHERING
