DESIGN INFORMATION BULLETIN NO. 83 - 04

CALTRANS SUPPLEMENT TO FHWA CULVERT REPAIR PRACTICES MANUAL

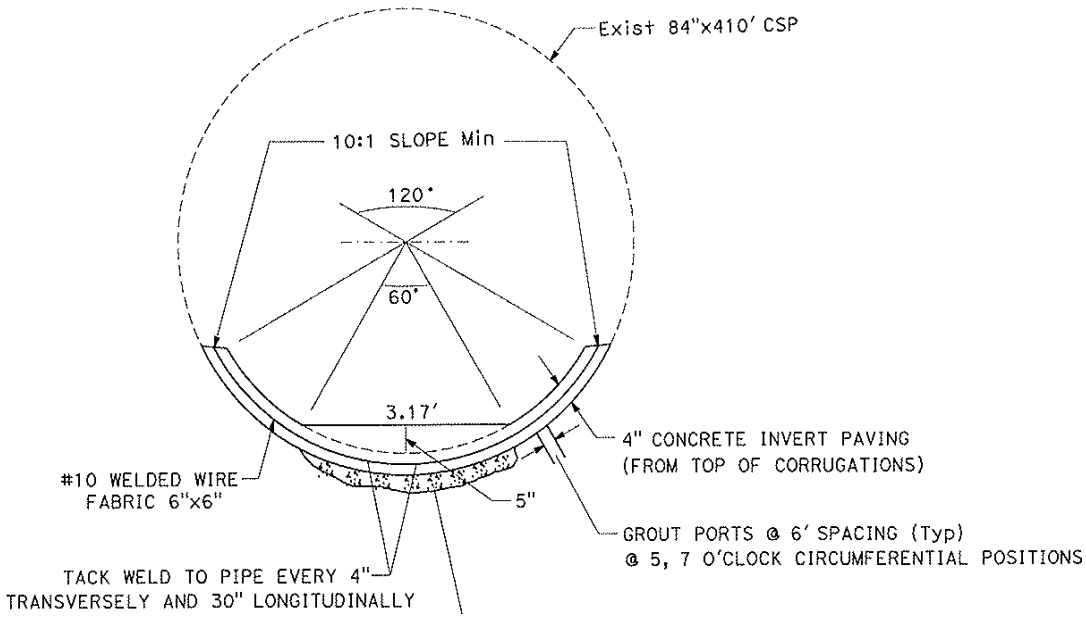
(Above) Example of Insufficient Concrete Invert Paving Design Thickness for Abrasion Level 6

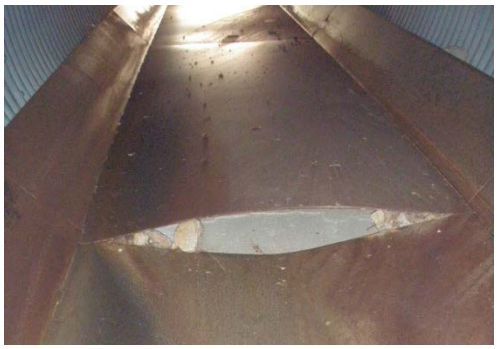
Insufficient Anchorage with No End Treatment

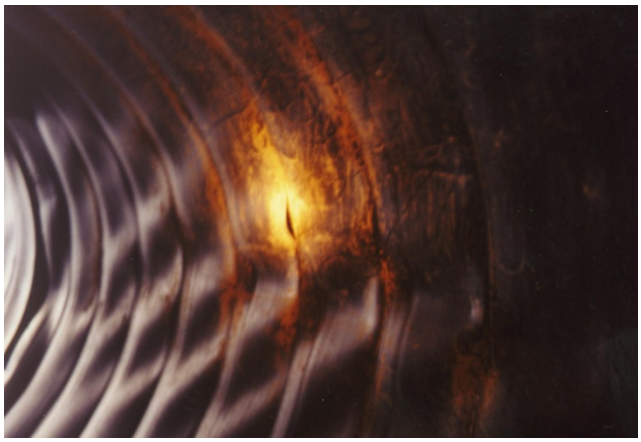
Profile of pipe: Note wall buckling and obvious oval shape. This 42 inch diameter pipe was installed in 1994. The pipe is 82 feet long and has a maximum cover of about 10 feet. Separations of the joints ranged from 1 to 3 inches. Rippling of the sidewalls is apparent throughout the length of the pipe (see below).

Small Crack and Wall Rippling

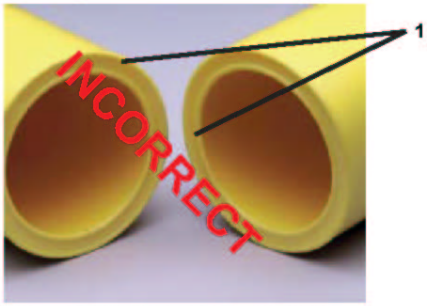
Figure 2 Unacceptable Concave Melt Appearance

1. Unacceptable concave melt appearance.

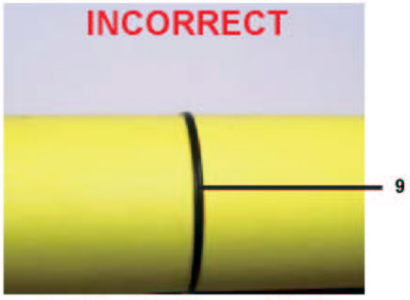
9. Insufficient heat time; melt bead too small

10. Excessive heat time or pressure applied during heating; melt bead too large

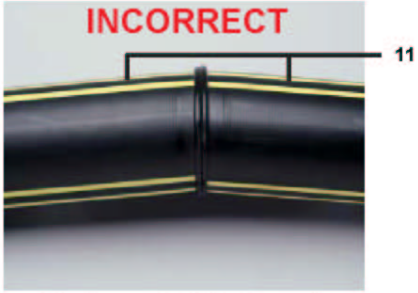
11. Pipe angled into fusion unit

12. Improper "High-Low" alignment

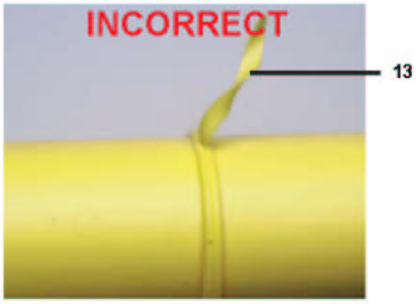
13. Incomplete face off or failure to remove faced off ribbons

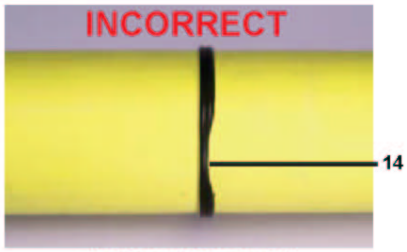
14. Incomplete face off

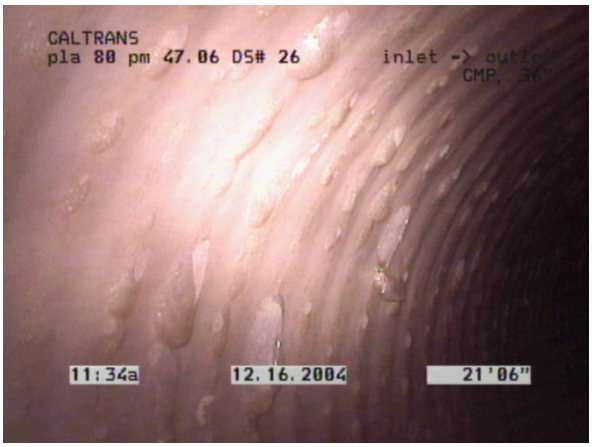
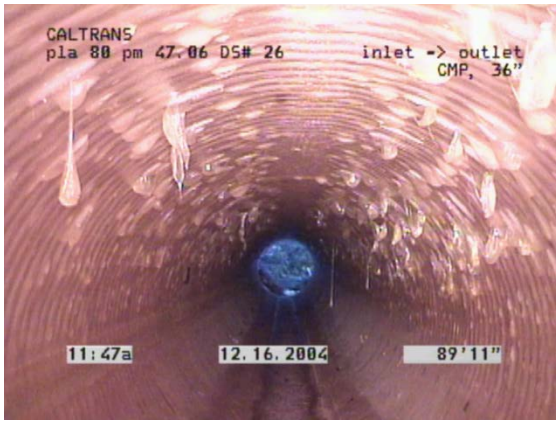
Examples of Delamination, Bubbling and Rippling in Lined CMP Host Pipes

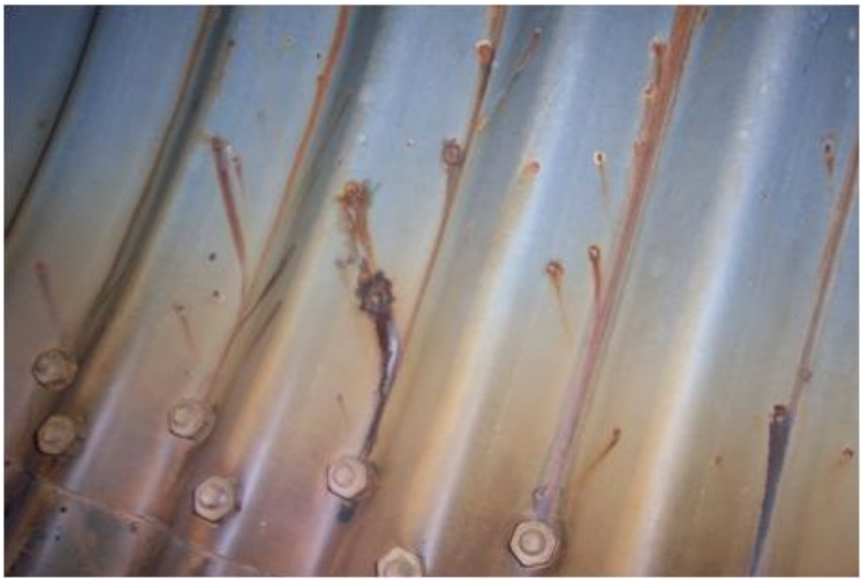
Total Loss of Invert and Existing Nuts Showing Minimal Wear

Typical Local Corrosion Cells. Note that the corrosion is coming in from the backside, thus the pipe is in worse condition than it appears. See picture of void found from probing during construction.

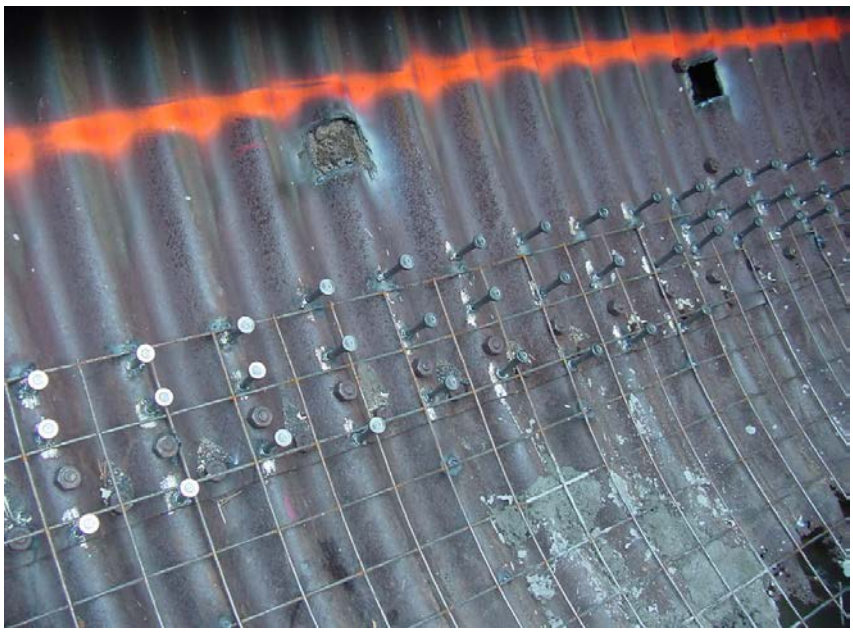
Before paving the invert, coupons were cut into the culvert wall in order to probe for voids. Most of the voids found were below the springline, however, a significant void was discovered near the outlet of the eastbound pipe above the springline at the 10 o' clock position. In both pipes the most significant voids were found at the inlet.

Coupons Cut in Sidewall of Culvert for Probing and Grouting

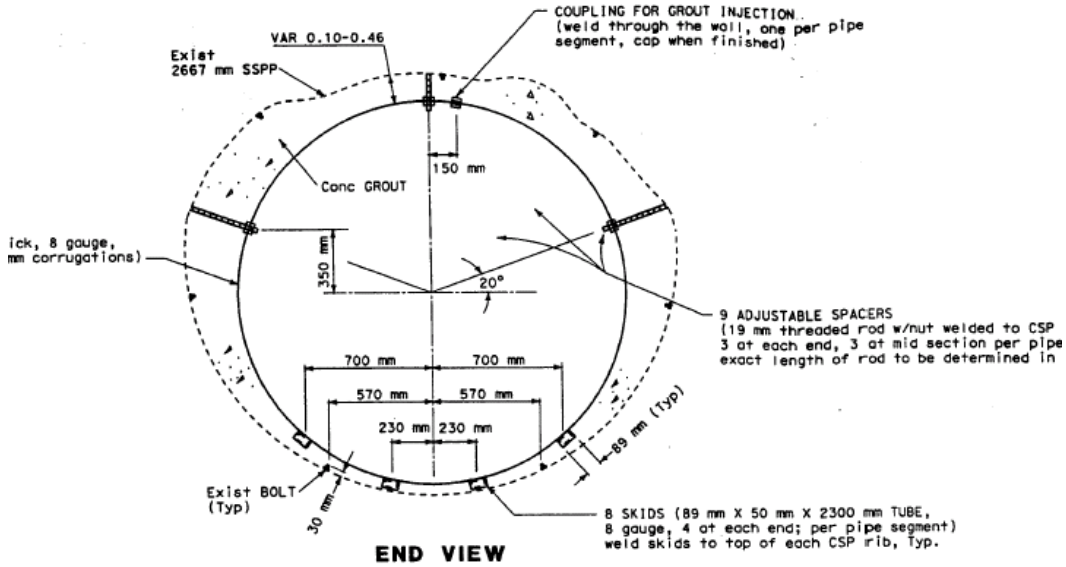
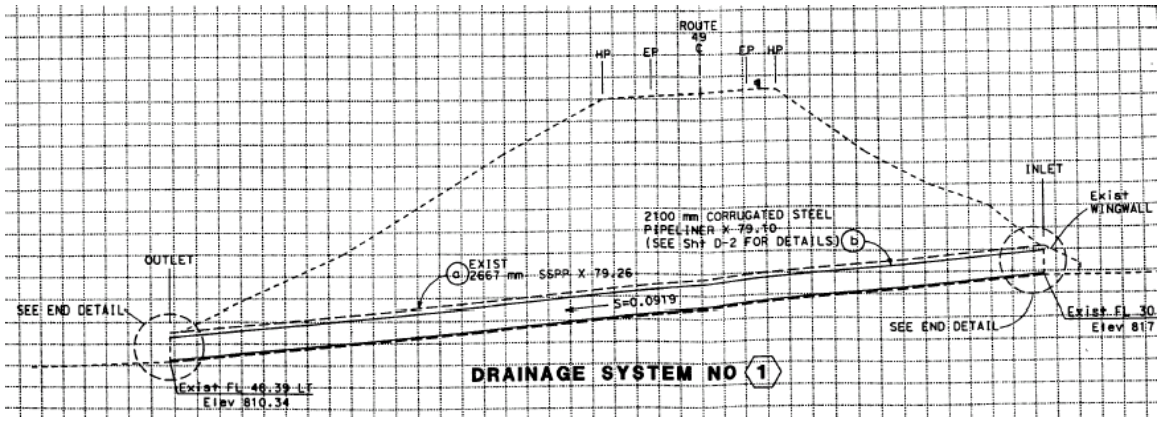
The resulting hydrostatic pressure at the downstream end from continuous grouting of the annular space between the existing culvert and the 84-inch CSP liner placed inside caused the liner to float and buckle with grout leaking out of the liner's joints which had been specified as watertight with gaskets. The grouting operation was immediately stopped and a Contract Change Order (CCO) was developed.

Grouting Through Grout Port in Soffit of Liner **Grout from Leaking Joints in Invert**
