# **US 101 (Broadway) K-Mart to 4th St**

**Pedestrian and Bicycle Road Safety Audit**

**Humboldt County, California**

**August 25-28, 2008**

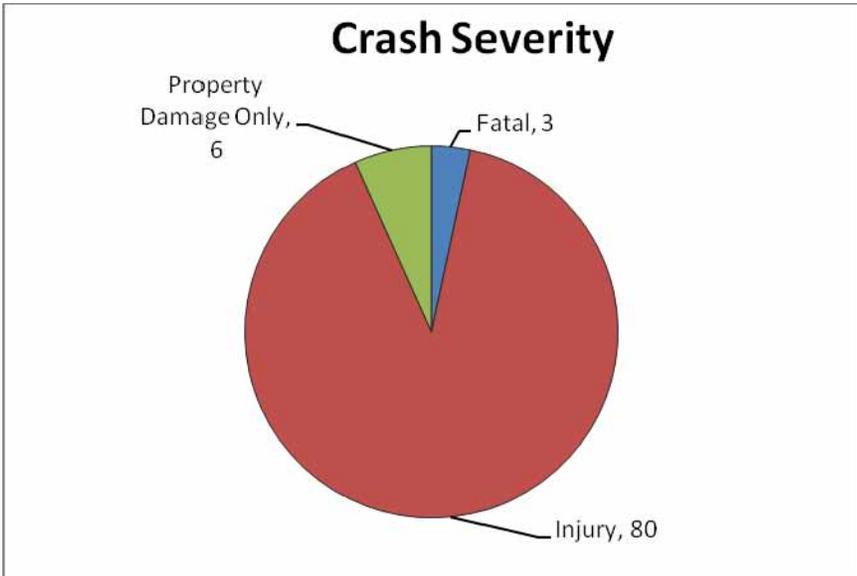
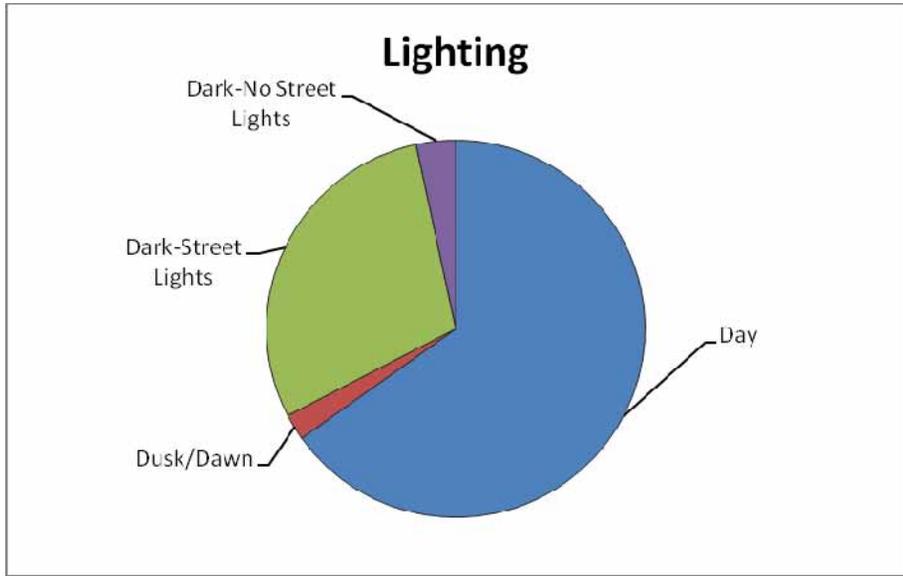
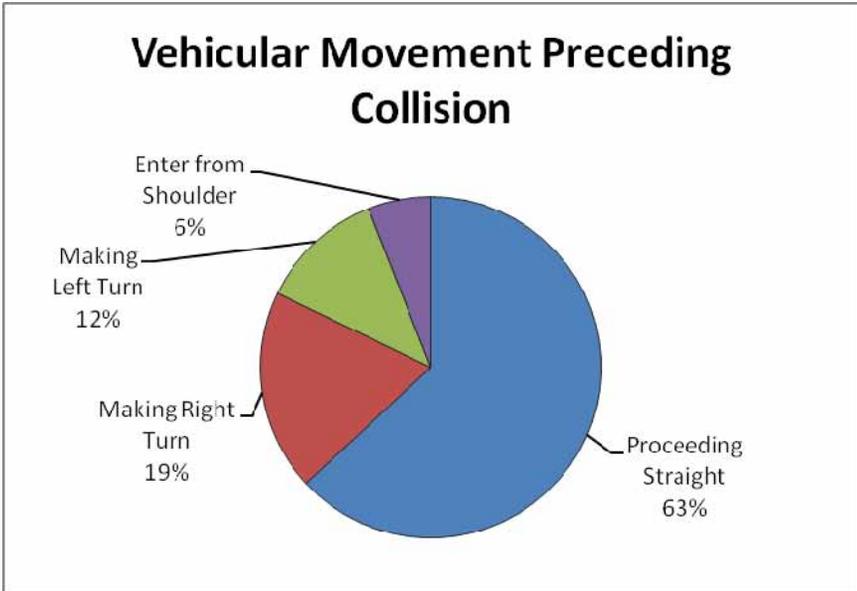
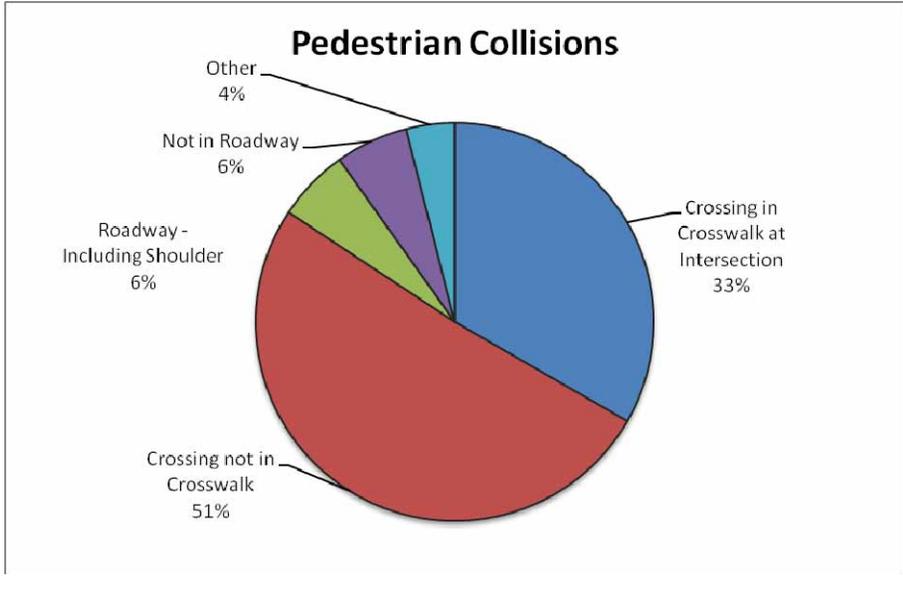
**Figure 2. Collision Analysis of Study Area**

and potential lack of expectancy on the part of the motorist of encountering a crossing pedestrian or bicyclist. The second most common vehicular maneuver preceding a collision was making a turn, which accounted for nearly 30 percent of the pedestrian- and bicycle-related collisions.

- Of the reported pedestrian collisions, over half of the collisions were not in the crosswalk and a third of the collisions were in the crosswalk. On highway shoulder and not in the highway accounted for another 12 percent of the pedestrian collisions. These data describe the vehicular movement preceding the collision and reinforces the fact that crossing-related collisions are the biggest concern, especially those not in the crosswalk.

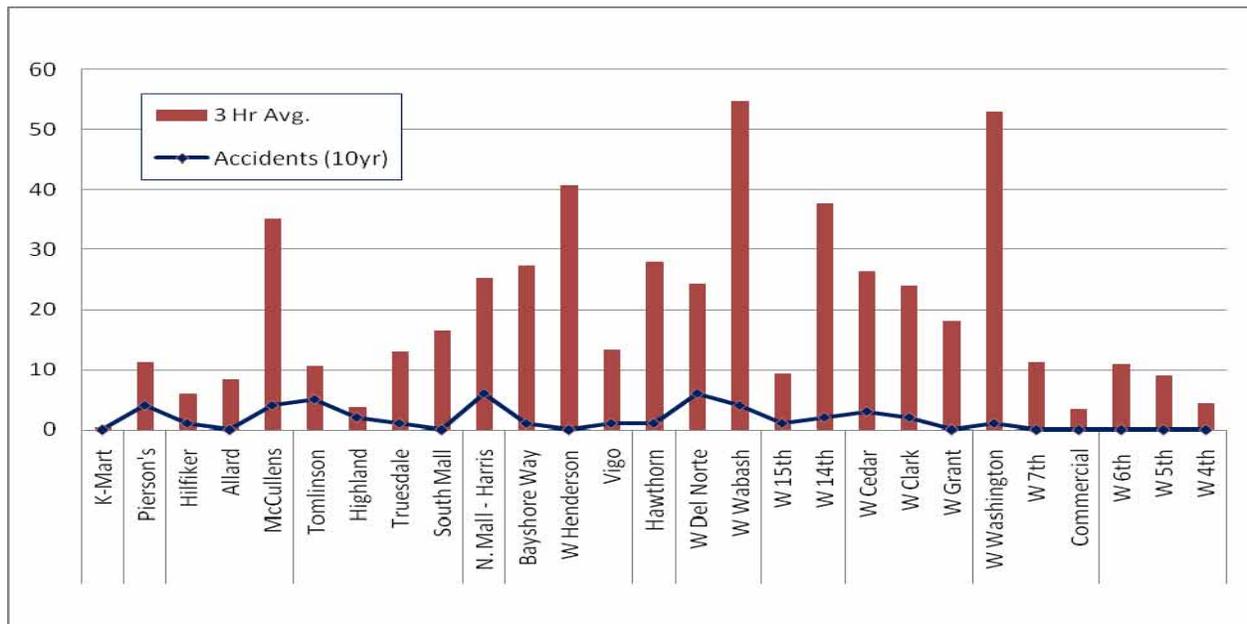
**Figure 3. Average Pedestrian Counts vs. 10-Year Ped/Bike Collisions**

Figure 3 shows the average 3-hour pedestrian counts described in Section 2.2 plotted with the 10 year total of pedestrian collisions. The areas of concern based on these data can be described as follows:

- McCullens Avenue.
  - North Bayshore Mall Entrance.
  - West Del Norte Street.
  - Wabash Avenue.
- *Areas with relatively low number of crossings and high number of collisions:* Fewer pedestrians are crossing at these locations and are involved in collisions as frequently or nearly as frequently as at crossings with higher usage. This may be an indicator of lack of driver expectancy, pedestrians crossing against the signal for various reasons, and/or insufficient guidance provided to motorists and pedestrians. Intersections that fall under this category include:

- Pierson’s Entrance.
  - Tomlinson Street.

Areas with a relatively high number of crossings and low number of collisions are desirable. A good example is Washington Street where the 3-hour average number of pedestrians crossing is over 50 and the number of collisions is relatively low (one collision).
