Appendix C. Captioned Photographs of Selected Sites

Racin, James A., Hoover, Thomas P., and Crossett Avila, Catherine M., **California Bank and Shore Rock Slope Protection Design - Practitioner's Guide and Field Evaluations of Riprap Methods**, report number FHWA-CA-TL-95-10, California Department of Transportation, Sacramento, CA, 3rd Internet edition, October, 2000, revised Appendix C, 1 Jan 2004.

Jim Racin, P. E. 1 Jan 2004 Office of Highway Drainage Design CA DOT Sacramento, CA.

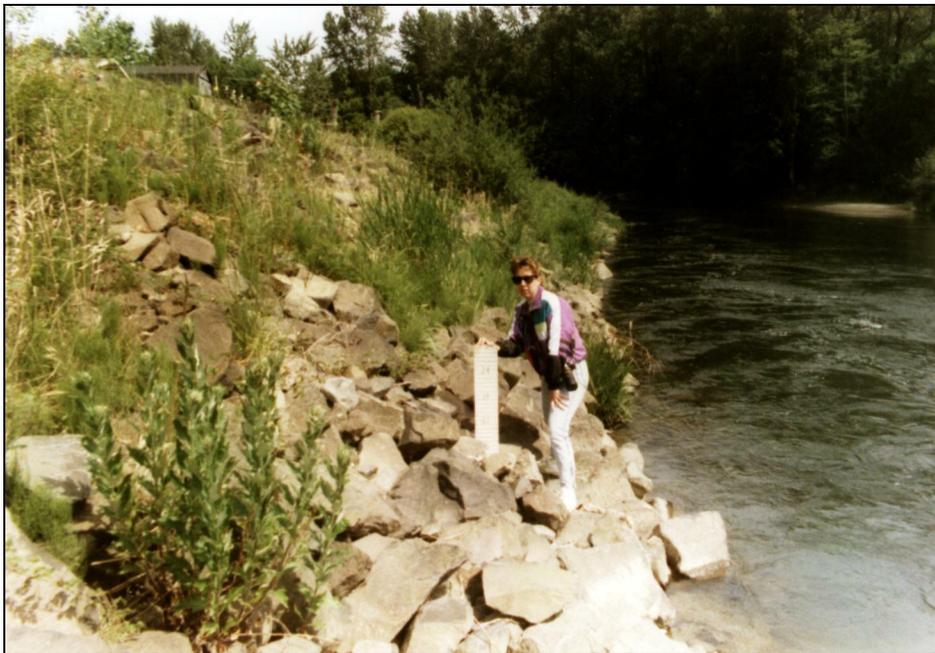
Photo C-2. Bank which gets impinging flow. D/S view. Design velocity was 16 feet per second.
Seattle Corps Class V riprap 1800#-25# W50 750#.
Observer holding white z-scale: 30-inches high by 5-inches wide.
Site 1 WA Nisqually R. May 1992

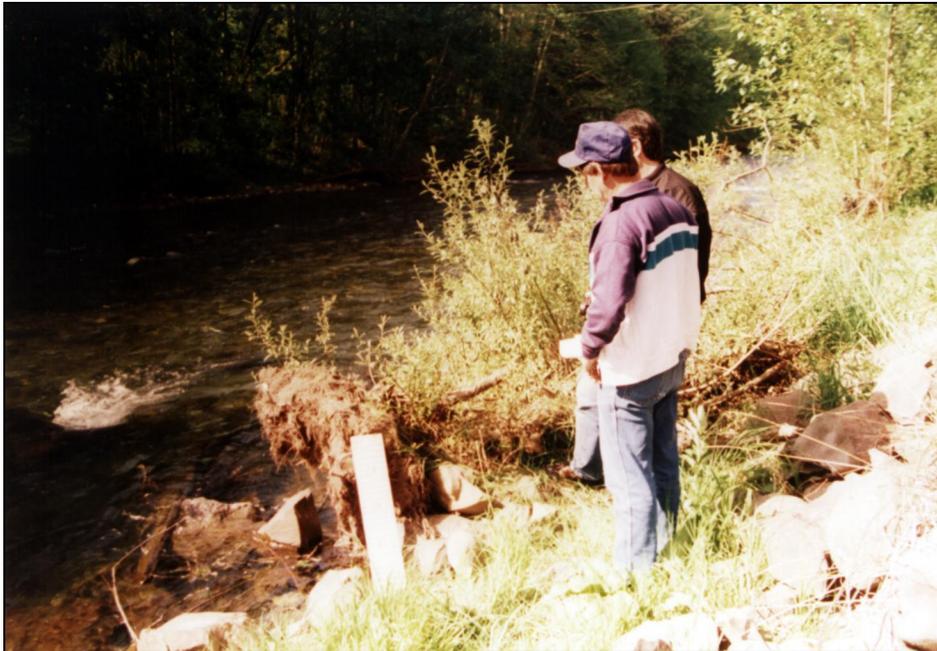
Photo C-8. Tree toppled by current. Flow is toward right. Volunteer tree is below elevation of normal high water. In WA state some dike districts require removing vegetation when it is greater than 2-inches in diameter at chest height. Site 4 WA Cedar R. Orchard Bend May 1992

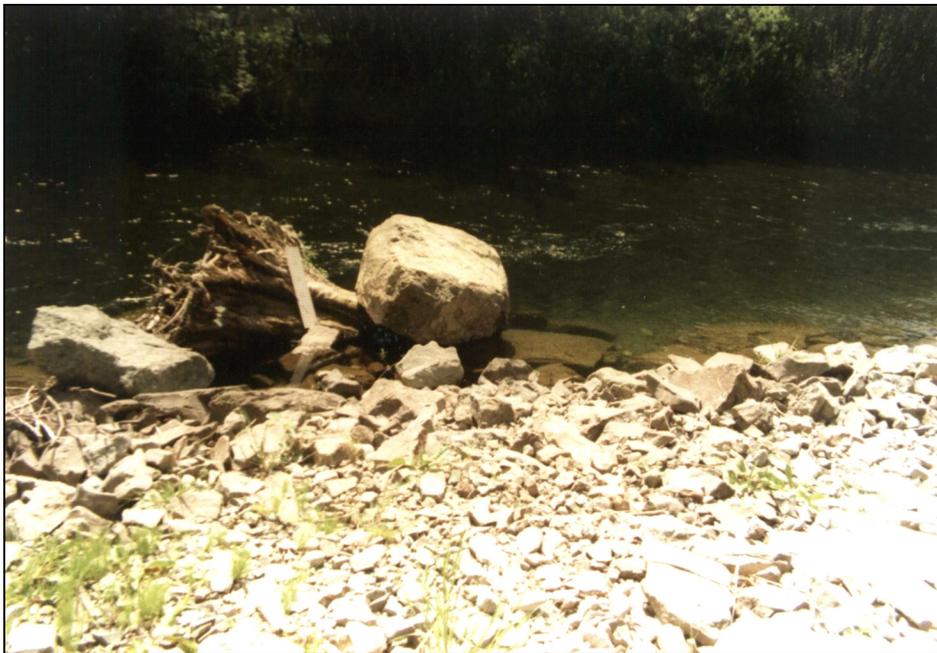
Photo C-10. Fish habitat structure. Flow is toward right. Tree stump anchored by large rock projects into stream, provides eddy for fish. Tree stumps are likely to float away at high stream stage unless secured with cables. 30-inch long by 5-inch wide z-scale leaning against stump.
Site 6 WA Cedar R. Rainbow Bend May 1992

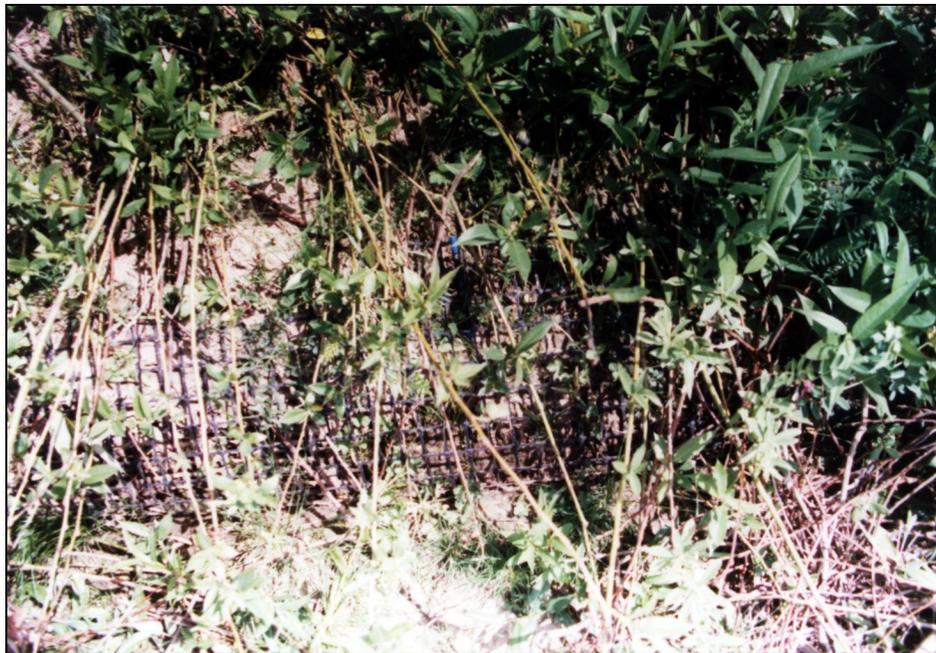
Photo C-12. Close-up of plastic geogrid gabion and vegetation. Square grids are on 1-inch centers. Pencil with blue top for scale at center of image. Site 7-B WA Green R. May 1992

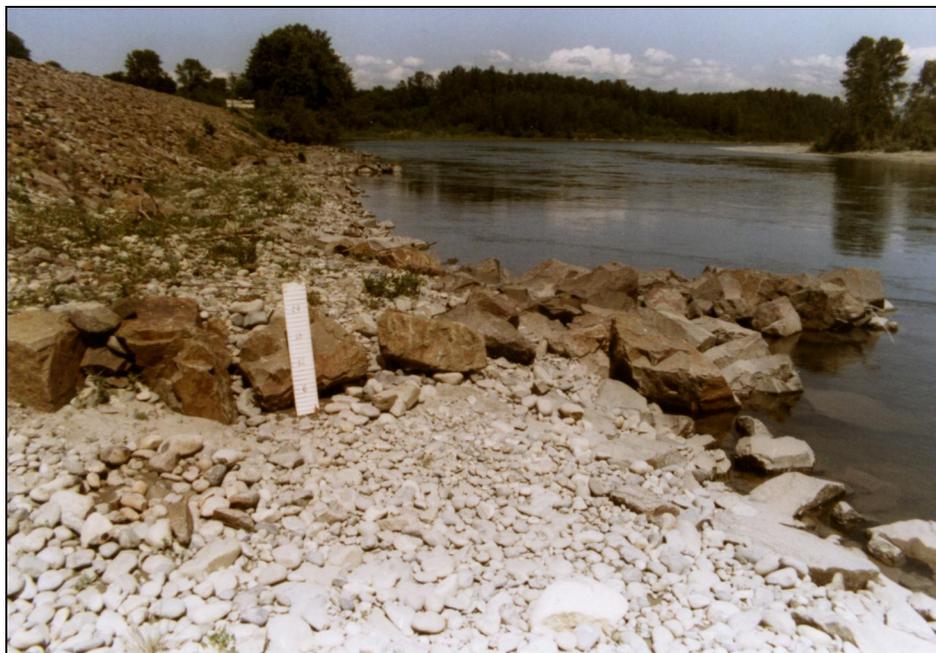
Photo C-16. Close-up of permeable rock jetty. U/S view.
30-inch high by 5-inch wide z-scale.
Silt-covered cobbles in foreground. Calm water at lower right, D/S of jetty.
Site 9 WA Skykomish R. May 1992

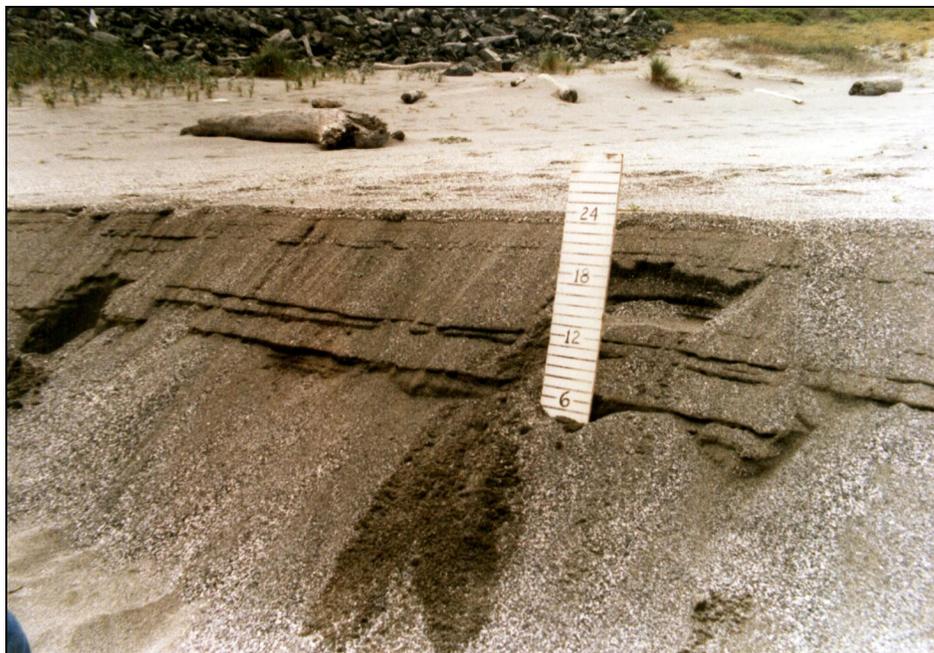
Photo C-20. Layers of deposited sand.
Side of channel shows different thicknesses of beach sand accretion.
30-inch high by 5-inch wide z-scale, inch graduations.
Site 11 OR Nesika Beach May 1992

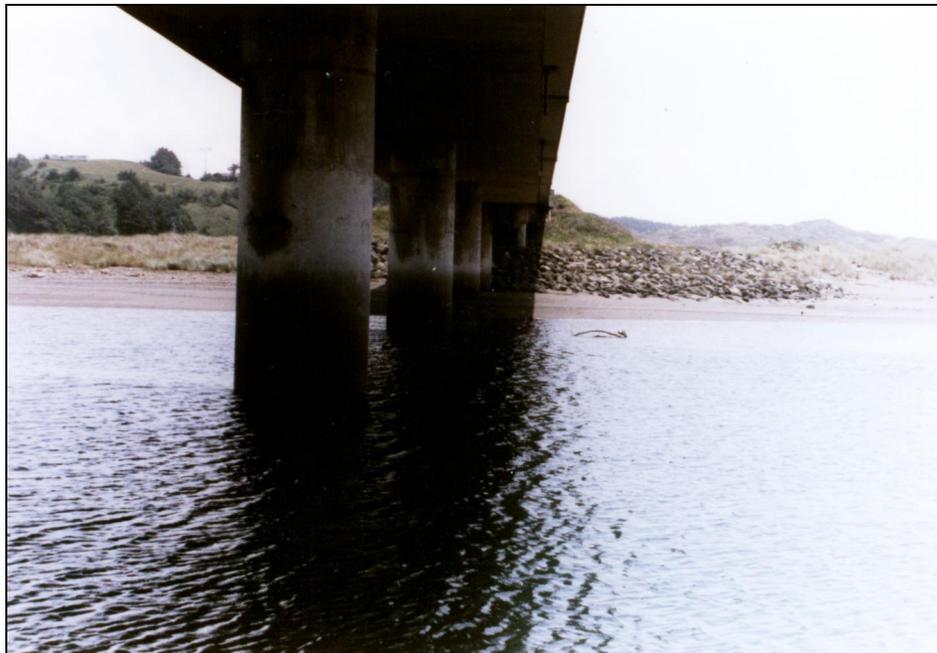
Photo C-22. Layered RSP protects bridge abutment fill. Southerly abutment fill. Layered RSP is (Class 2000, Class 50, geotextile). River flows toward right at low and ebb tides. Channel to ocean on right.
Site 12 OR Pistol R. and Beach 19 May 1992

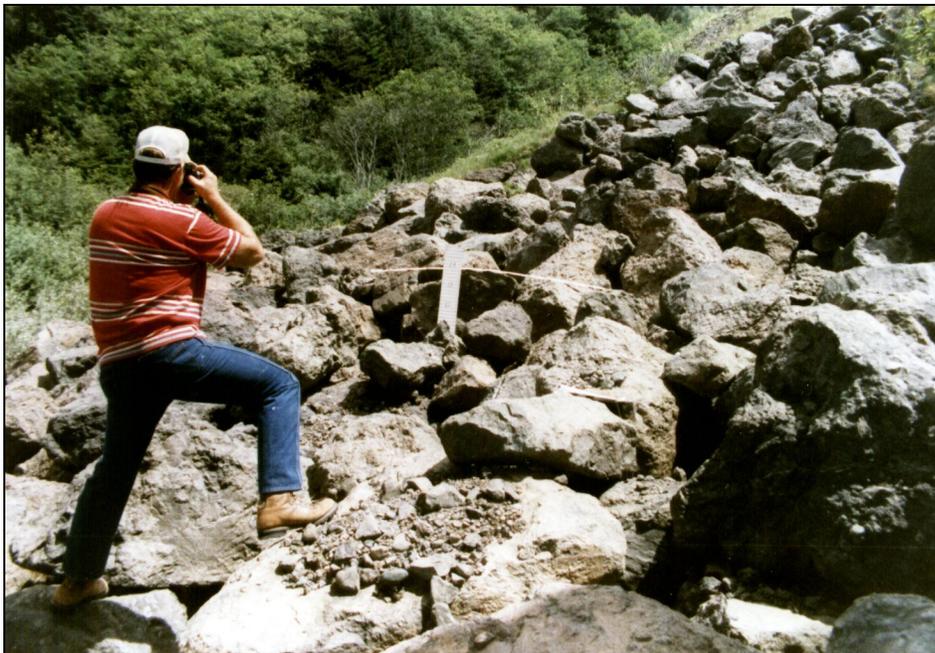
Photo C-26. Outside layer (primary cover stone) 2070#-1240#. View of Southerly abutment riprap. Fewer rocks displaced as contrasted to standard Class 2000. 30-inch high by 5-inch wide z-scale and 6-foot wide folding rule.
Site 13 OR Myers Creek and Beach 19 May 1992

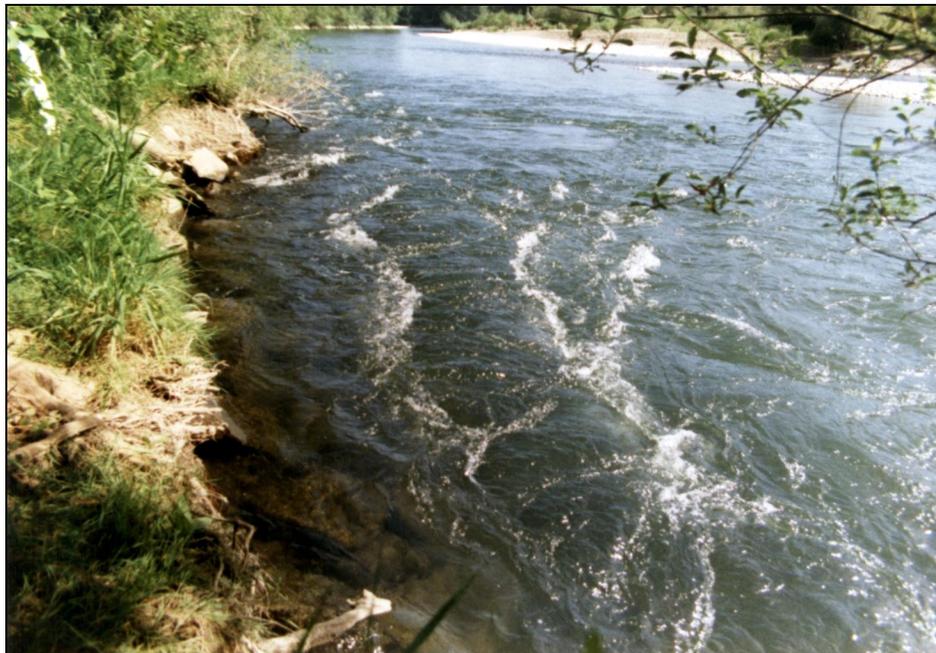
Photo C-32. OR Keyed Riprap, close-up at left bank. D/S view at impinging zone. Class III (800#-25# W50 300#) over 1-foot Class 50 filter layer. Rock is visible below surface. Natural siltation and vegetation about 3-feet higher than water surface. Site 15 OR South Santiam R. May 1992

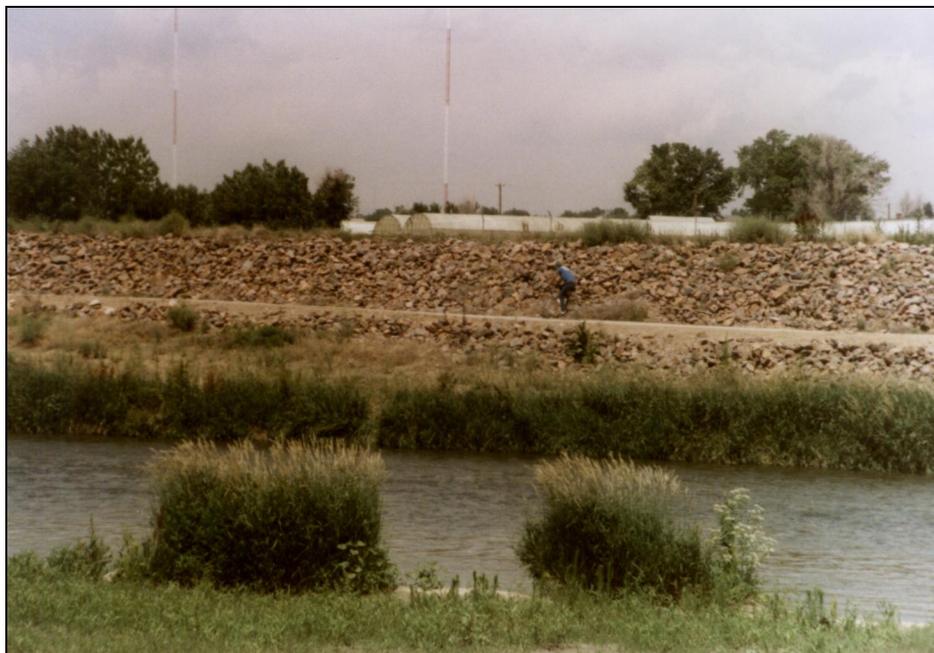
Photo C-40. Natural growth contrasted to non-revegetated riprapped dike. View: across river. Foreground growth is on gravel bar island. Riparian vegetation grows in naturally deposited soil pockets in riprap below bikeway. Bikeway built at stage of about Q5, riprapped dike built above stage of Q100. Cyclist near center of image. Site 21 CO South Platte R. 16 Jun 1992

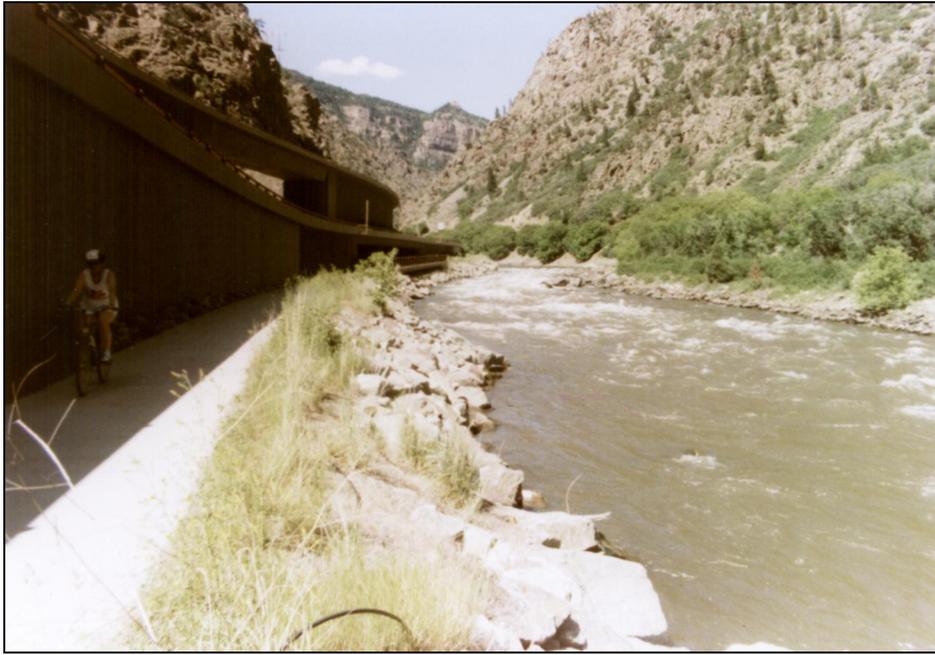
Photo C-47. Rough surface boundary created with riprap. U/S view. CO DOT HEAVY riprap. Rough boundary enhances habitat by providing current eddies and voids among rocks. Bikeway was built at stage of Q5. Cover soil placed over HEAVY riprap for revegetation with occasional voids where soil washed through. Site 27 CO Colorado R. 17 Jun 1992

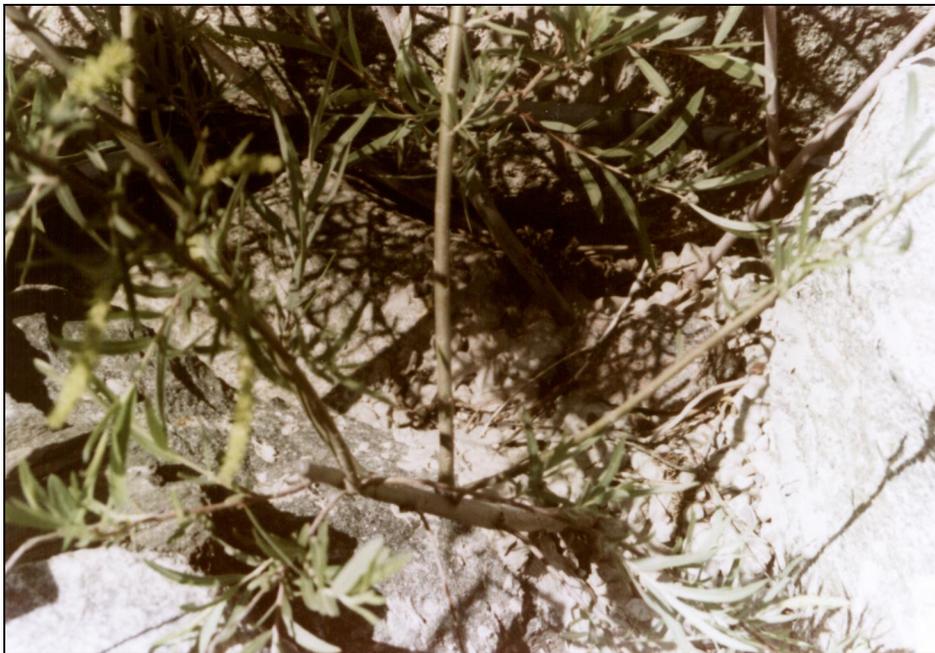
Photo C-48. Willows growing well through concreted-RSP. View normal to riprap. Experiment by CO DOT : willows were planted among riprap voids, then concrete was placed. Result : willows grew OK. I-70 Glenwood Canyon Bikeway, Grizzly to Shoshone. Site 27 CO Colorado R. 17 Jun 1992

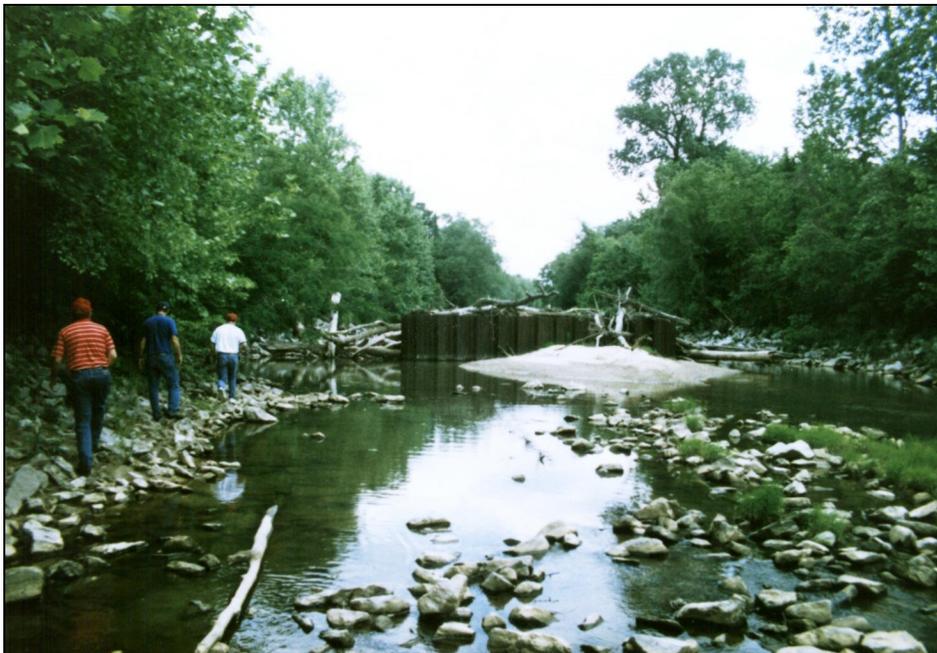
Photo C-60. Concrete-filled, steel-pile baffle. U/S view. Baffle is about 25-feet D/S of grade control structure in Photo C-59. Randomly interlocked log snags on U/S side of baffle provide habitat and nutrient value for fish and other aquatic life. Site 47 MS North Fork Tillatoba Cr. 20 May 1993

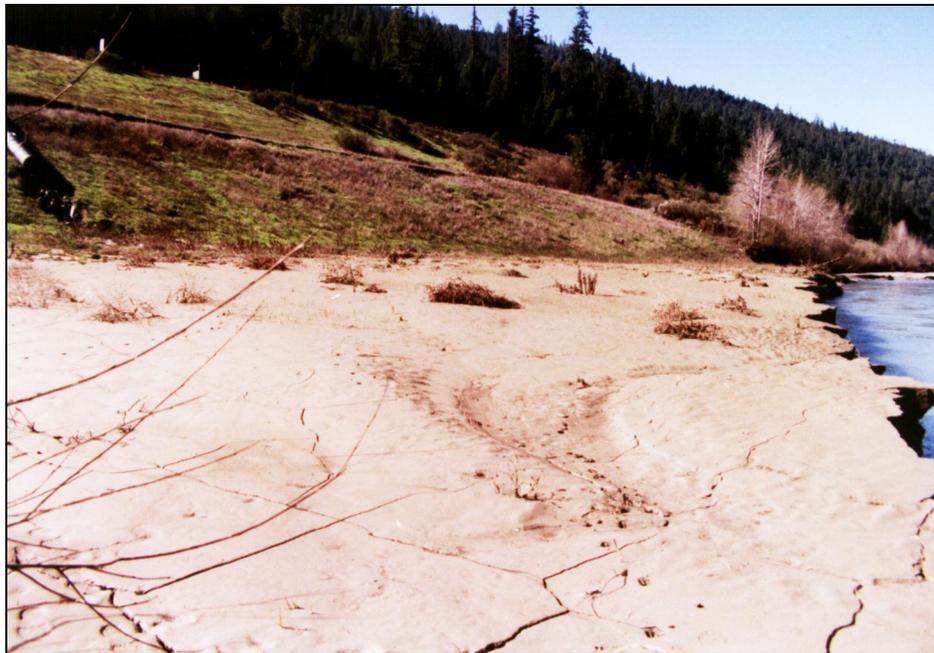
Photo C-66. Unstable silt deposit, 6-feet thick. D/S view of bank in Photo C-65. Triangular plan view dimensions of silt +50 feet wide x 350 feet along ditch, and top of silt is about 75 feet below US 101.

"Fish-cluster rocks" buried under silt after 1 wet season. Cover-soil eroded to RSP below 36-inch culvert (upper left of image). Site 55 CA South Fork Eel River 13 Feb 1996

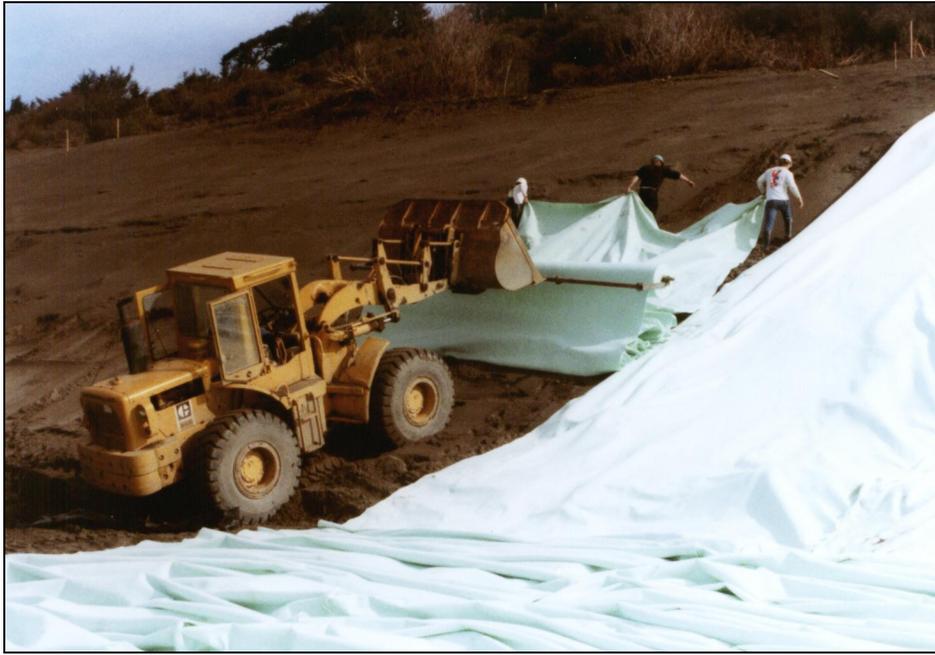
Photo C-69. Loader-mounted dispenser holds 20' wide x 250' long roll of RSP-fabric. View from pit bottom. 12-oz/sqyd nonwoven needle-formed geotextile, ultraviolet stabilized, made from virgin and recycled plastics (tinted green from pop bottles). Specially designed Z-fold pattern (by Racin) on pit bottom gives extra length of RSP-fabric to fall into anticipated scour holes with rocks as undermining occurs. Site 59 CA Mad River 11 Feb 1992

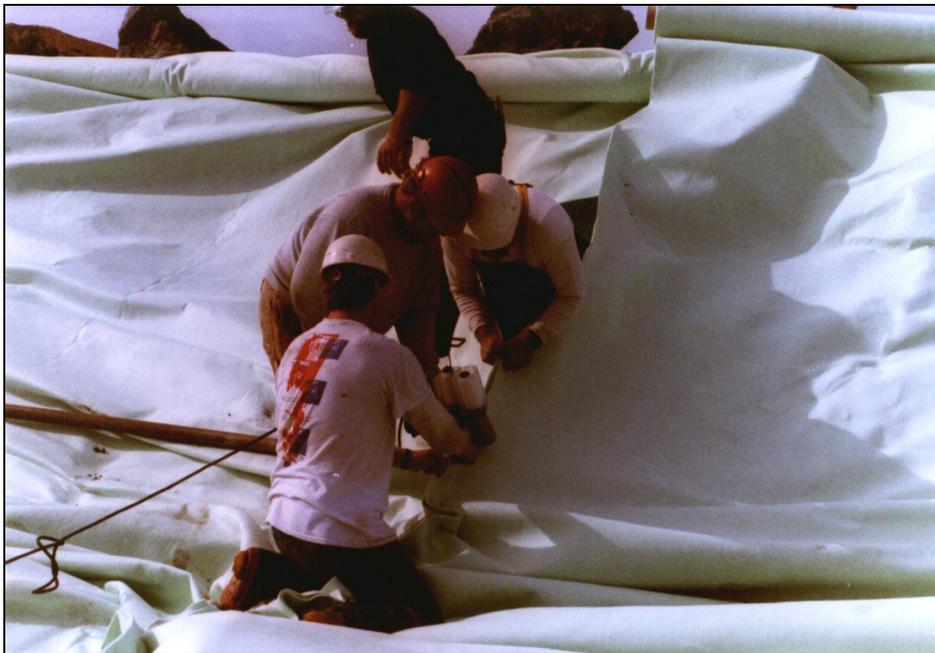
Photo C-70. Four-man team positioned and sewed RSP-fabric. From top to bottom of bank, one continuous prayer seam was stitched with nylon thread. Seam strength \geq RSP-fabric strength of 300-lb grab tensile strength was achieved. Stitched seams are required in this (and similar) severe setting of river currents and ocean tides. Site 59 CA Mad River 11 Feb 1992

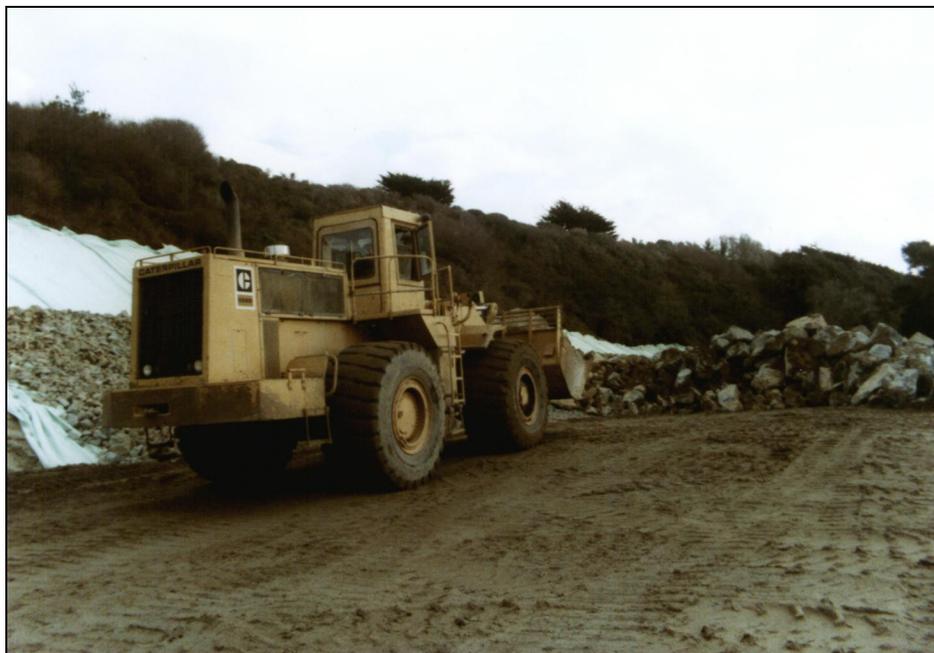
Photo C-72. Thin sand layer on Backing No. 2 protects rubber tires of equipment during turning movements, prevented rubber tires from getting chewed-up by angular rocks of backing layer. Southerly view in pit. Sand layer is not needed to protect RSP-fabric from backing or outside layers of rock, because Caltrans specifies RSP-fabrics to survive normal riprap construction, via specified toughness values. Site 59 CA Mad River 11 Feb 1992

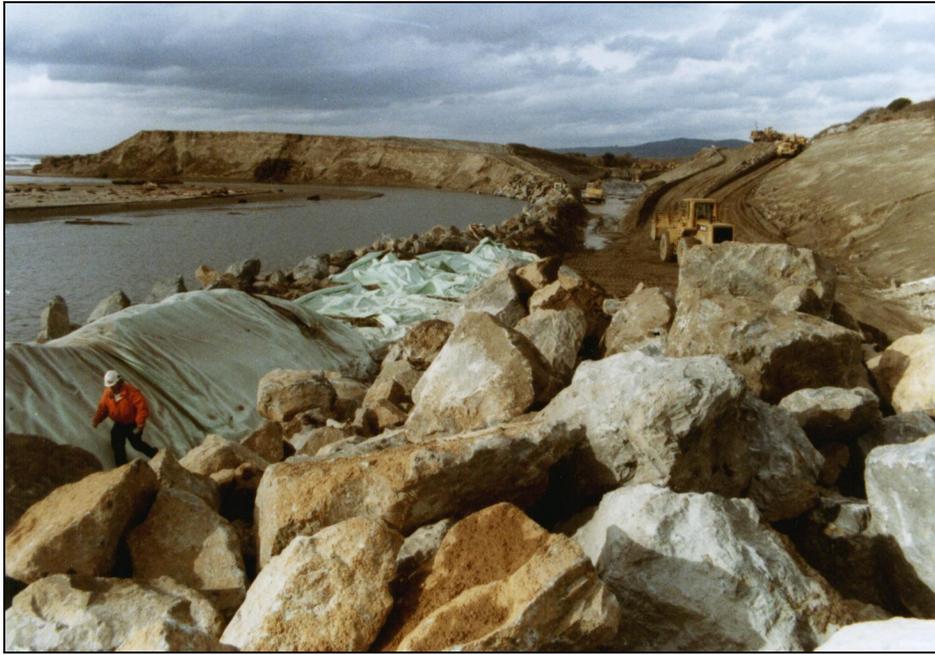
Photo C-73. Inspecting special rock mixture, 8-ton maximum. Northerly D/S view, Mad River at left. Large launch rocks were placed individually by rubber-tired loaders. Although mixture is designed to launch, some interlock is needed. Excavated pit (at sea level) was pumped after storms due to seepage from high river stages and above-normal tides. Site 59 CA Mad River 11 Feb 1992

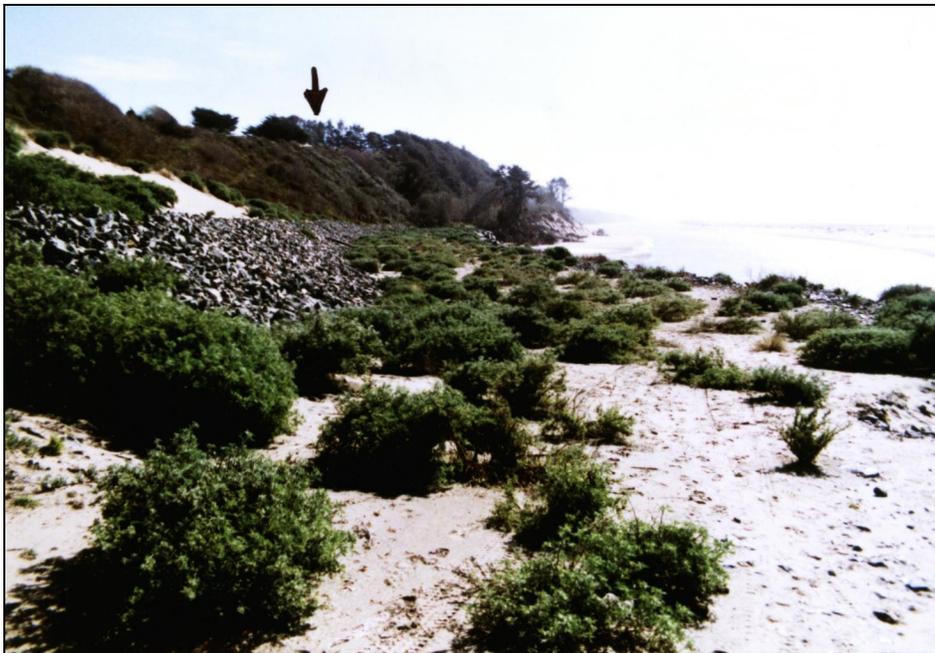
Photo C-74. Mad River RSP facility after 2 years. U/S southerly view. Mad River and ocean sand spit at right, Mckinleyville / US 101 vista point marked by arrow. Layered riprap built in pit : RSP-fabric, Backing No. 2, and special launchable 8 ton rock mixture (mounded toe concept). Covered with sand layer and revegetated naturally. Site 59 CA Mad River May 1994

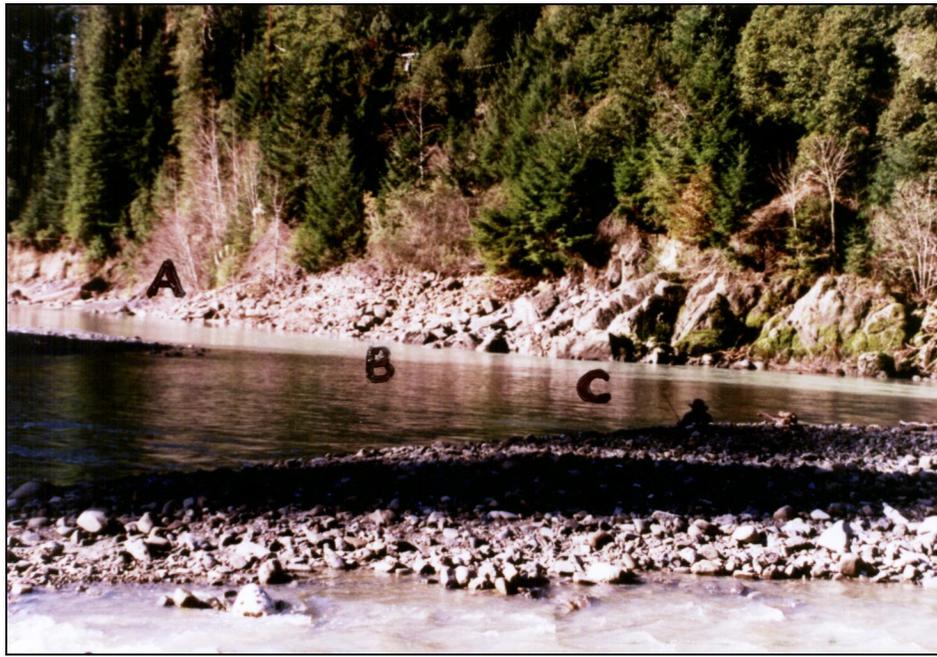
Photo C-81. RSP tied to natural rock outcrops. 1996 D/S impinging view. A, B, and C mark sites of 1993 Photos C-82, C-83, and C-84 respectively. Grizzly Creek (at bottom) flows (to left) into Van Duzen. Silhouetted fisherman (right of C) sits where Creek thalweg was in 1993, on 5-foot thick gravel bank from Creek watershed. Van Duzen turns left around point bar (shadow at left below A).

Site 56 Van Duzen River 15 Feb 1996

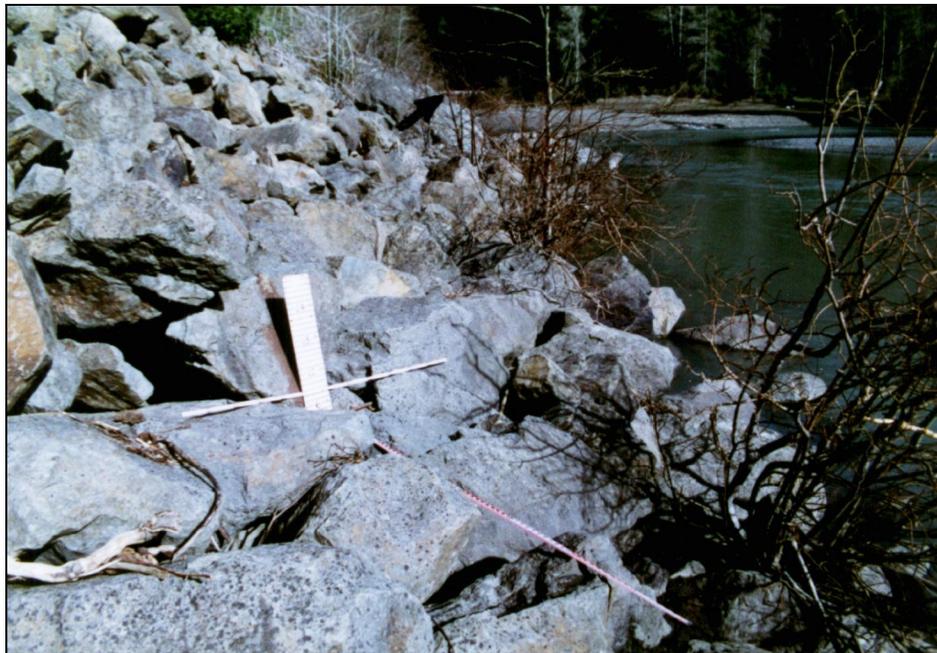
Photo C-82. Toe stabilized with 4 ton RSP-class, upper bank is 1 ton. U/S view, near A in Photo C-81. Arrow (near top center) marks rail of former bridge over Grizzly Creek, (replaced in 1996), gravel bar and Grizzly Creek inflow (top right of center). Van Duzen opposite bank point bar (by upper right edge).

Site 56 Van Duzen River 3 Feb 1993

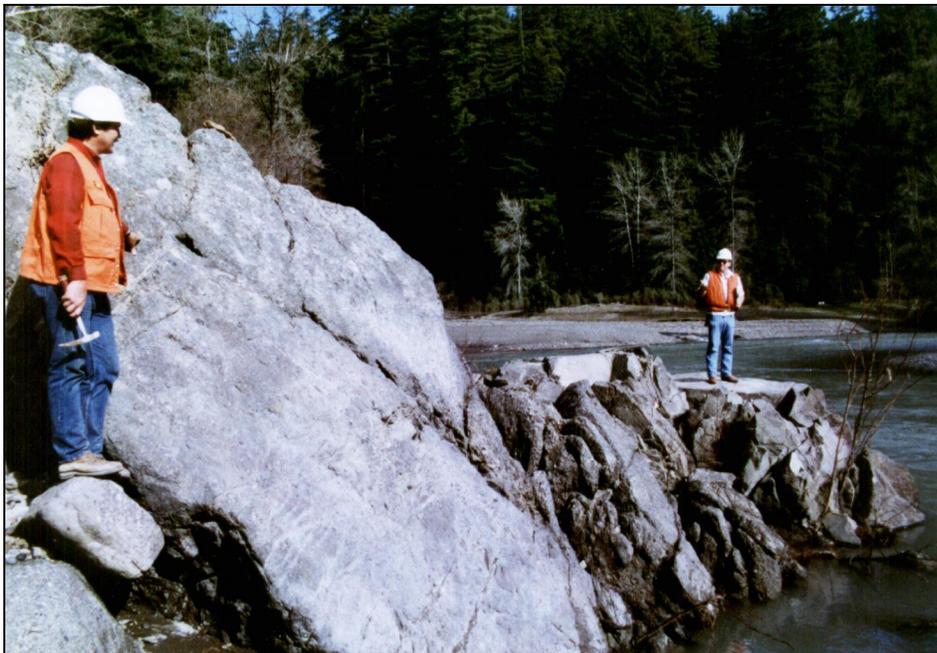
Photo C-84. Level line between observers' hats is near highest observed water (1964). U/S view, near C in Photo C-81. Grizzly Creek thalweg flows through gravel bar into Van Duzen (behind right observer). Grizzly Creek State Park campground (above gravel bar) was submerged about 7 feet in 1964 floods.
Site 56 Van Duzen River 3 Feb 1993

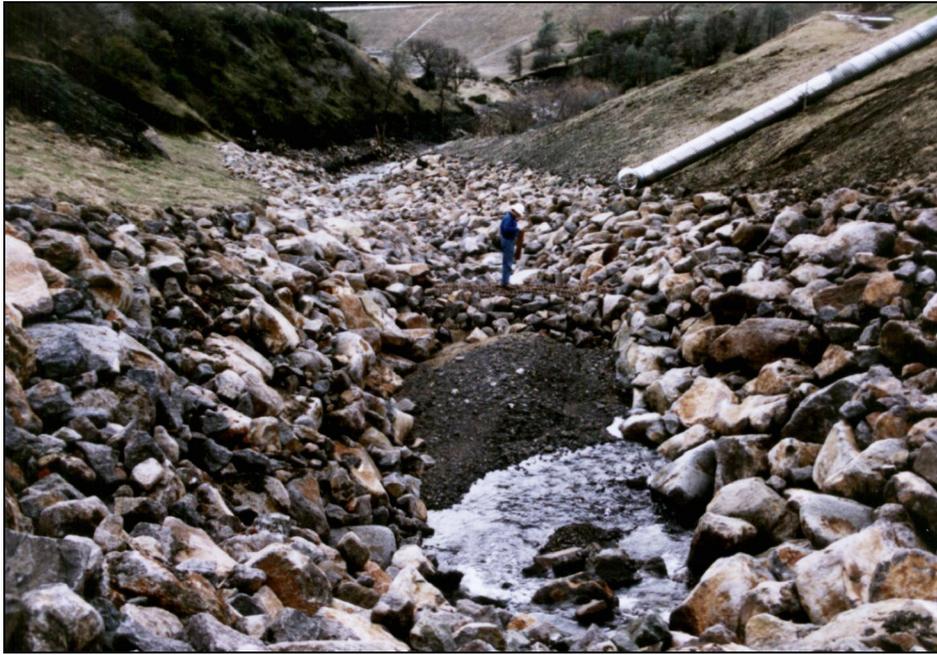
Photo C-89. Sediment fan in stilling pool behind gabion weir grade control structure. D/S view just above the lower downdrain seen in Photo C-87. 6'-2" tall observer is standing on weir crest. Channel drop into dissipater / stilling pool is steeper than 21 %. Channel invert has smaller rock, about 1/4 ton RSP-class, spread on top of 1 ton RSP and oversized rock mixture. Site 60 CA Grizzly Cr. 2 Feb 1996
